GABINETE DE PREVENÇÃO E INVESTIGAÇÃO DE ACIDENTES COM AERONAVES
(G.P.I.A.A.)

INCIDENT REPORT
WITH AN AIR LUXOR **AIRBUS**,
MODEL **A-320**, REGISTRATION
CS-TQE
OCCURRED IN MADEIRA AIRPORT
ON THE 2ND OF JANUARY OF 2004

TECHNICAL REPORT Nr. 01/INCID/2004

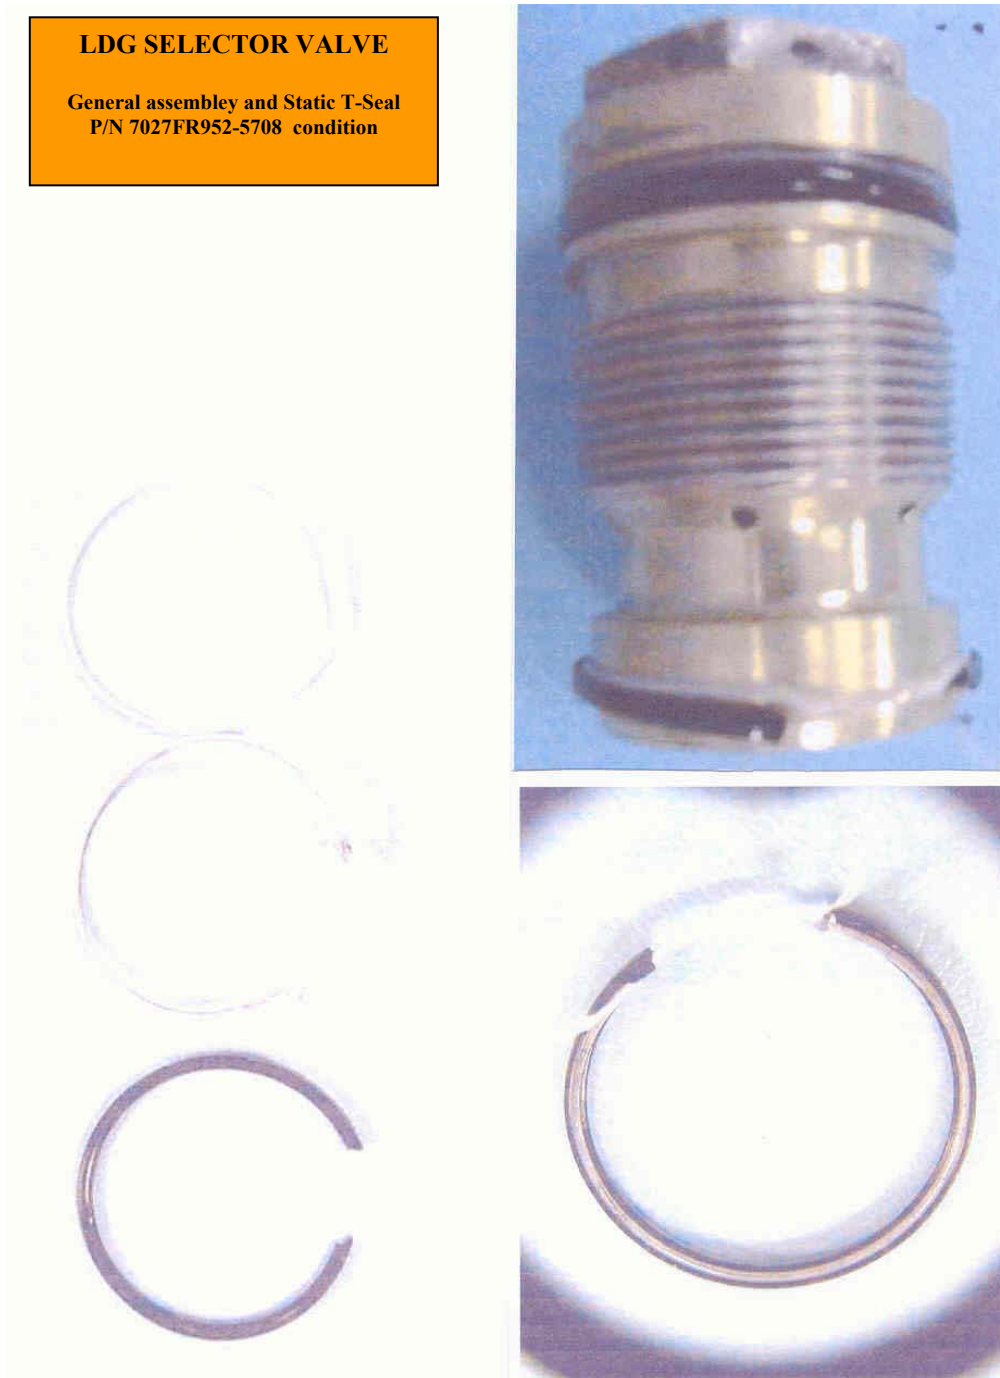
Picture Nr. 6

After disassembly (*picture 5 & 6*) an installation error was detected regarding a sealing ring (P/N 7027FR952-5708).

This irregularity allowed the oil to pass into return line and actuate the valve, pressurising the gear retraction line (*picture 7*).

The inspection carried out by Smiths Aerospace confirmed an installation flaw during selector valve manufacture process.

- 3.1.11 This anomaly was due to a deficient manufacture process.
- 3.1.12 This anomaly induced an abnormal pressurisation of landing gear retracting line.

In view of these findings and considering that the recommendations 4.2, 4.3 and 4.4 stated in SCF/SYS/N/09/7430 have been implemented, the Investigation Commission recommends that Airbus issues a Service Bulletin to mandate all operators, using the same type of landing gear selector valve, to perform an inspection of static seals for any assembly fault.

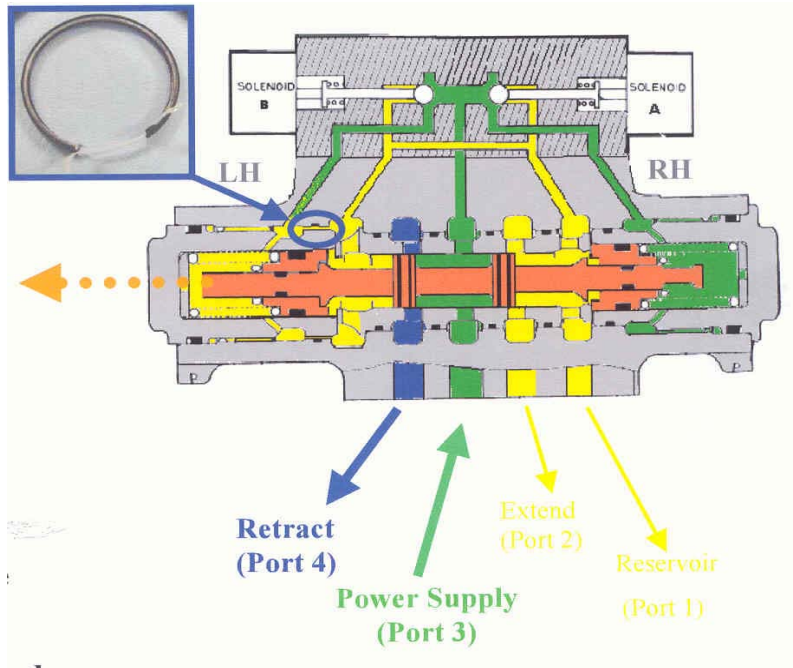
Picture Nr. 7

As we mentioned on 1.16.3, the faulty seal (*P/N 7027 FR 952-5708*) was responsible for this to happen (*picture 7*) and the line was pressurised (*picture 8*).

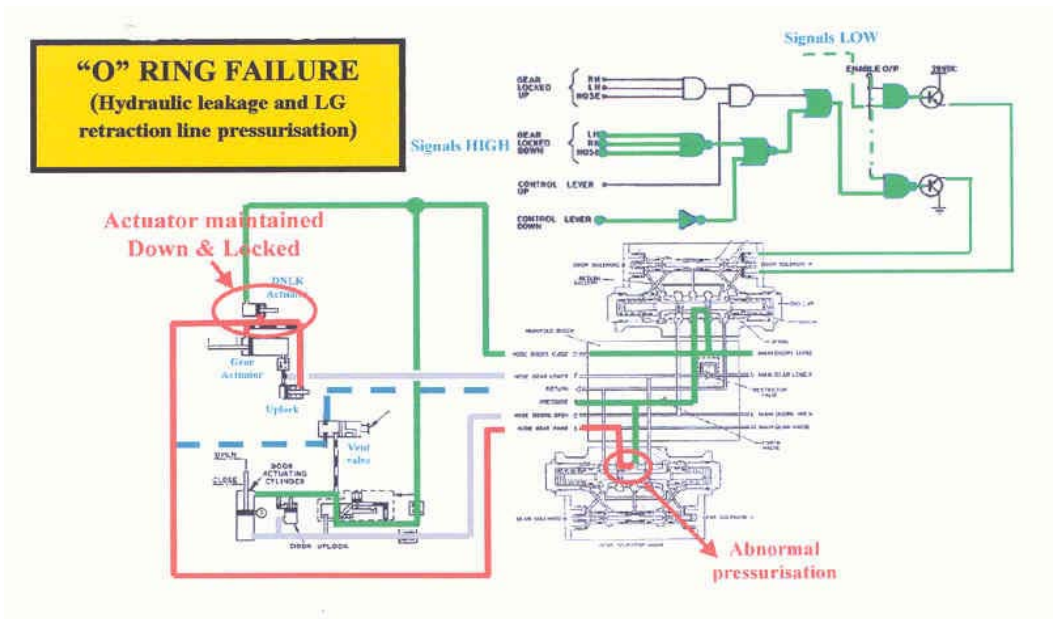
Picture Nr. 8

Even so, this pressurisation should be no sufficient to raise the gear because the LG doors closing line should be pressurised and securing the LG downlocks (*picture 8*), once “A” solenoid was supposed to be energized.

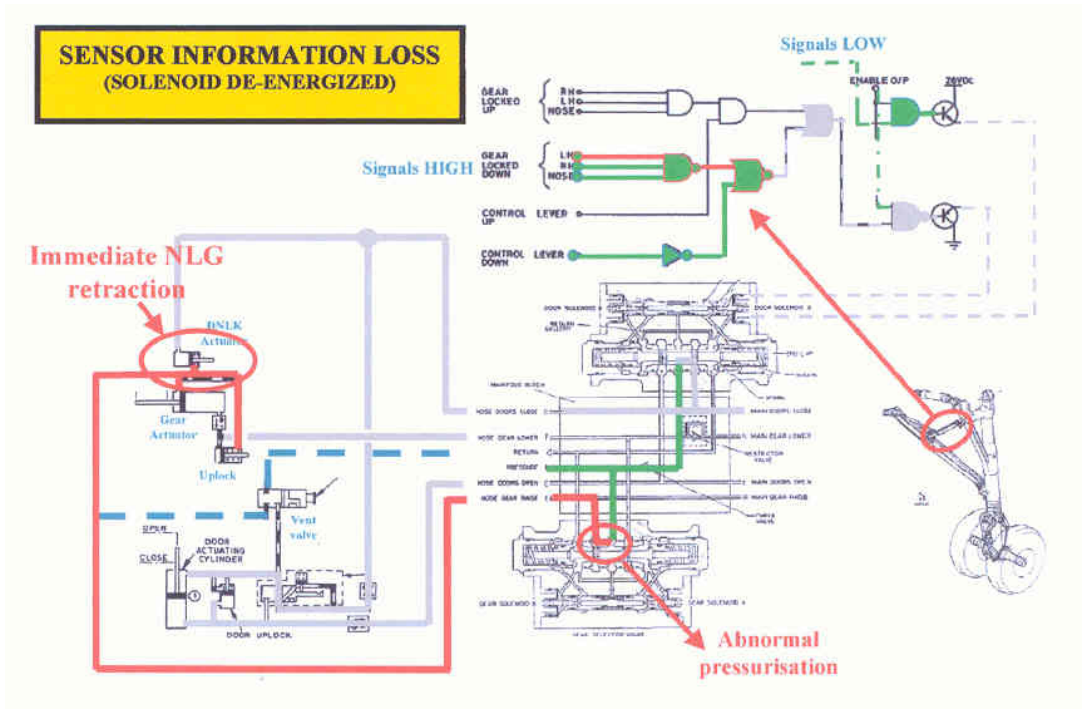
Picture Nr. 9

During complementary tests a proximity sensor on LHM gear strut was found momentarily deficient, suggesting it could de-energize the valve solenoid and permit a pressure drop in door closing line, allowing the NLG downlock to be withdrawn by gear raising pressure (*picture 9*).

This erratic failure, in conjunction with abnormal pressurisation of gear retraction line (due to sealing ring anomaly) could lead to the uncommanded gear retraction.

Even so, this fault was not enough for the gear to be raised. Pressure in gear doors closing line was sufficient to keep gear downlocks activated and prevent gear retraction. A pressure drop, in this line, was needed to allow the downlocks to be withdrawn (*picture 9*).

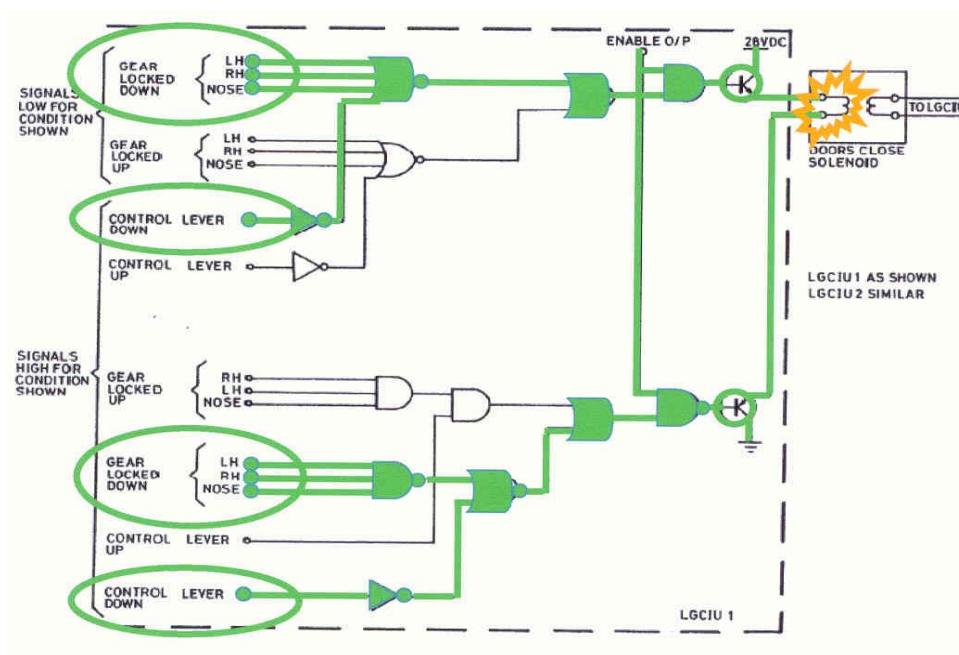
Picture Nr. 13

Door operating valve solenoids are commanded by either LGCIU, in response to gear lever selection and dedicated sensor signals (*picture 13*).

During tests carried on by Airbus, one of these sensors (*LH main gear down and locked*) was detected faulty, in some circumstances, and it was considered

this could induce the solenoid de-energizing and cause a drop in door closing line pressure, allowing LG downlocks withdrawal and making LG retraction possible.

This seems to be a hasty conclusion, considering there are two LGCIUs with independent sensors, any LGCIU will switch over to the other, in case of malfunction or sensor signal loss, and a warning will be displayed in cockpit.

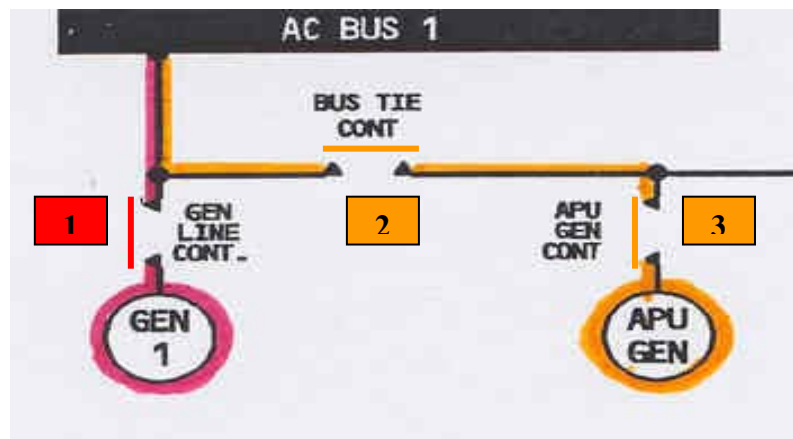
Picture Nr. 17

Whenever there is a power transfer, there is a transient, momentary period, during which the respective bus is not powered (picture 17).

When engine #1 was started and GEN 1 got ready to supply AC BUS 1 (*picture 17*), the BTC (2) was opened, cutting APU power from AC BUS 1, thus allowing GLC (1) to close and feed AC BUS 1, without mixing currents from different generators.

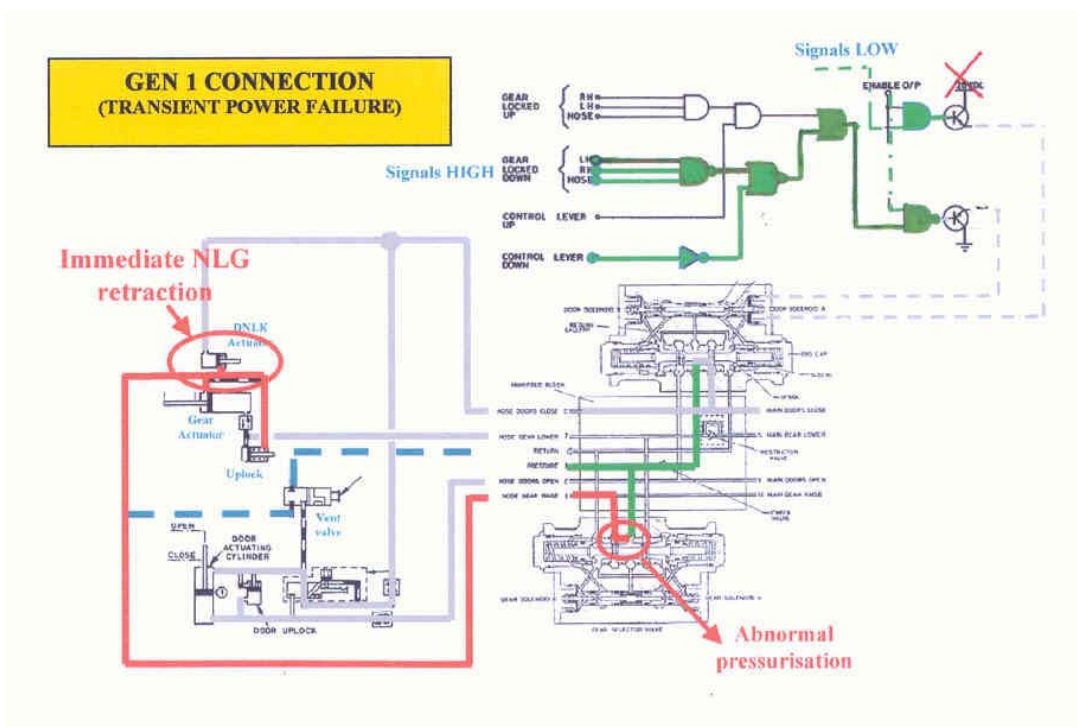
Picture Nr. 18

At that precise moment AC BUS 1 and, consequentially, DC ESS BUS were unpowered and the LG doors operating valve solenoid “A” was de-energized. LG doors selector valve reverted to neutral position and hydraulic pressure in doors closing line dropped momentarily. LG retracting line abnormal pressure could then withdraw LG downlocks and NLG was retracted (*picture 18*).

These transients are common with this kind of electrical system and they never let a registry on flight recorders, which may explain the absence of landing gear malfunction or abnormal indication reports.
