FINAL ACCIDENT REPORT

AIR TRACTOR - 802A

EC-JLB

FINAL ACCIDENT REPORT Nr. 12/ACCID/2012

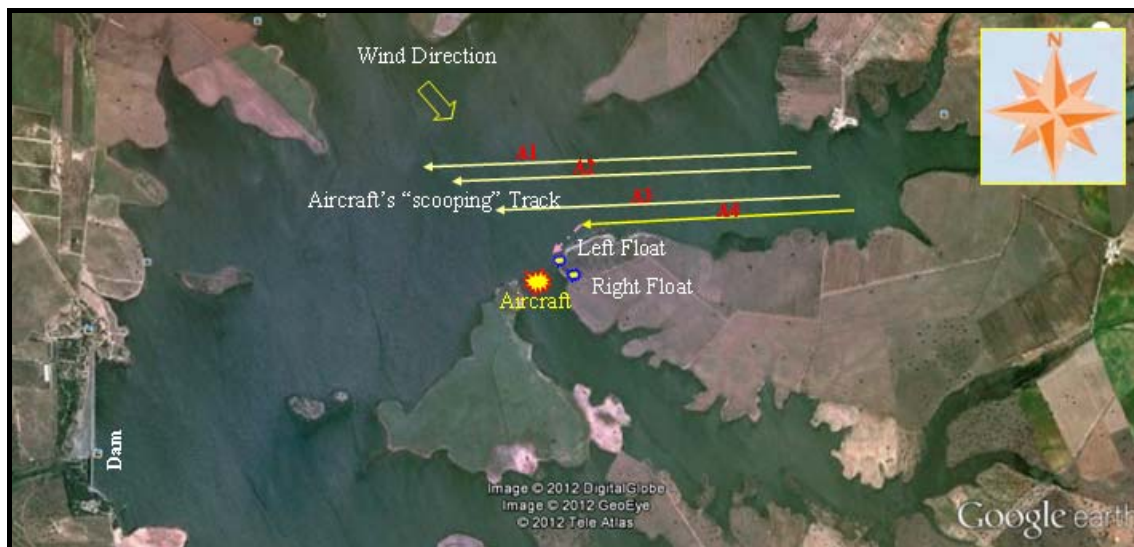
Picture Nr 2

After refuelling, the pilot accelerated for take-off and, when close to lift-off speed, entered wake turbulence zone, created by preceding aircrafts, got serious control problems, actuated emergency water discharge lever and when control was recovered, the aircraft was pointing about 45° to the left of intended heading. Before he could lift-off, aircraft floats collided with the ground in the lake margin and left float detached. The aircraft flew over a small

neck of land and crashed, nose down, some meters ahead in another inlet, right float broke up (becoming afloat and drift) and the aircraft sunk, almost immediately (*picture nr 2*).

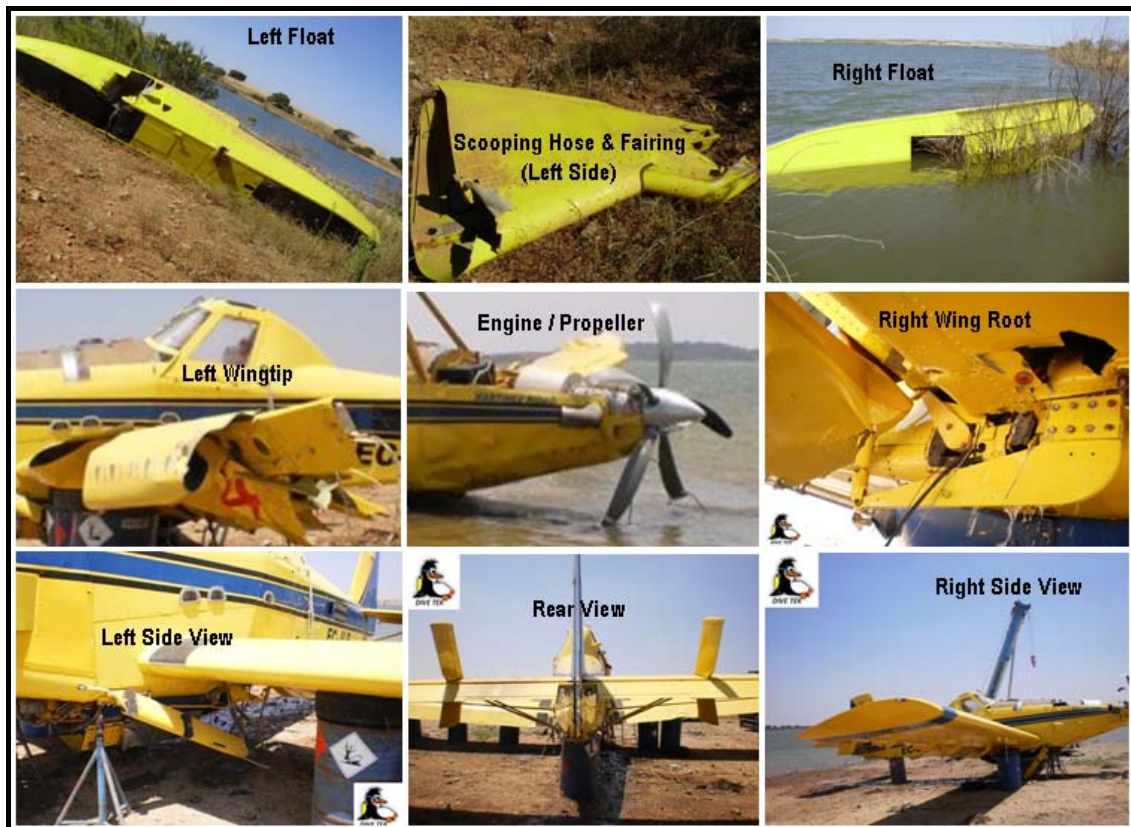
Picture Nr 3

The aircraft suffered substantial damage, which could justify not to be repaired, namely both floats separation and heavy damage to their fixing points and floats themselves, left wing tip and outer wing damage caused by water impact, right wing underwing crack (near its root) with fuel tank leak, bent propeller blade tips and light damage (scratches and dents) on fuselage skin and flight control surfaces (*picture nr 3*).

Being the aircraft immersed in the water it's supposed to have suffered equipment and engine substantial internal & external damage.

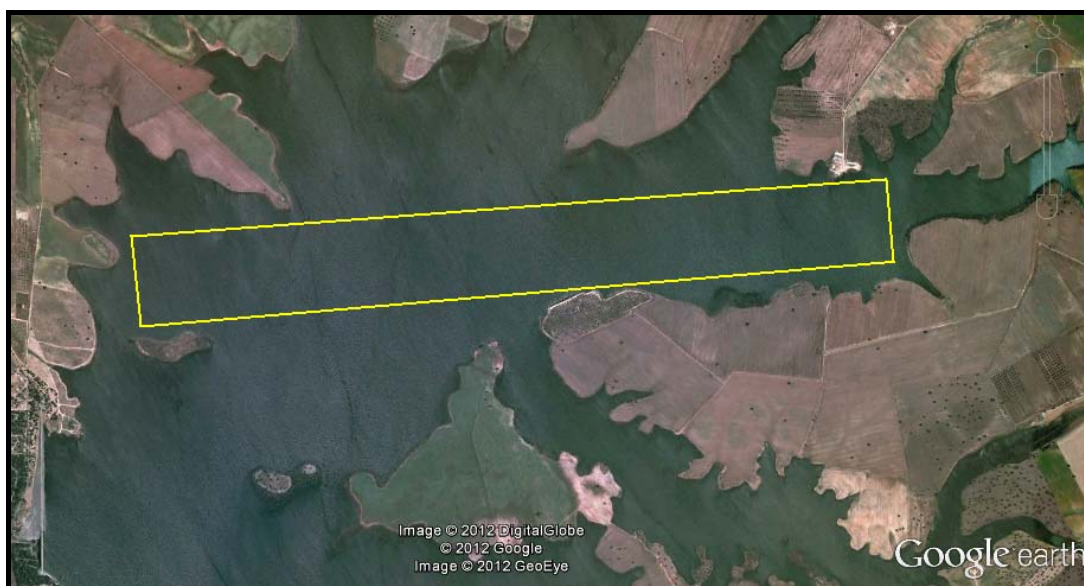
Picture Nr 6

Roxo Dam is located approximately 10NM Southwest of Beja military aerodrome and, at that time it was at a relatively high water level, which, given the absence of obstacles in its margins, no significant high grounds and no electric power lines in the zone, rendered it favourable for scooping operations. Taking a true heading of 265° (the wind was blowing from 310°), it was possible to draw a virtual runway with 13100ft X 1300ft (*picture nr 6*), well above the needs for this kind of aircraft operations.

After a sequential take-off, by 12:10, the four aeroplanes flew in group towards "Roxo Dam" and proceeded directly for scooping, always in group, on a true heading of 265° approximately, being that the best heading to grant the biggest and widest virtual runway available, more suitable for the group manoeuvre (*picture nr 6*).

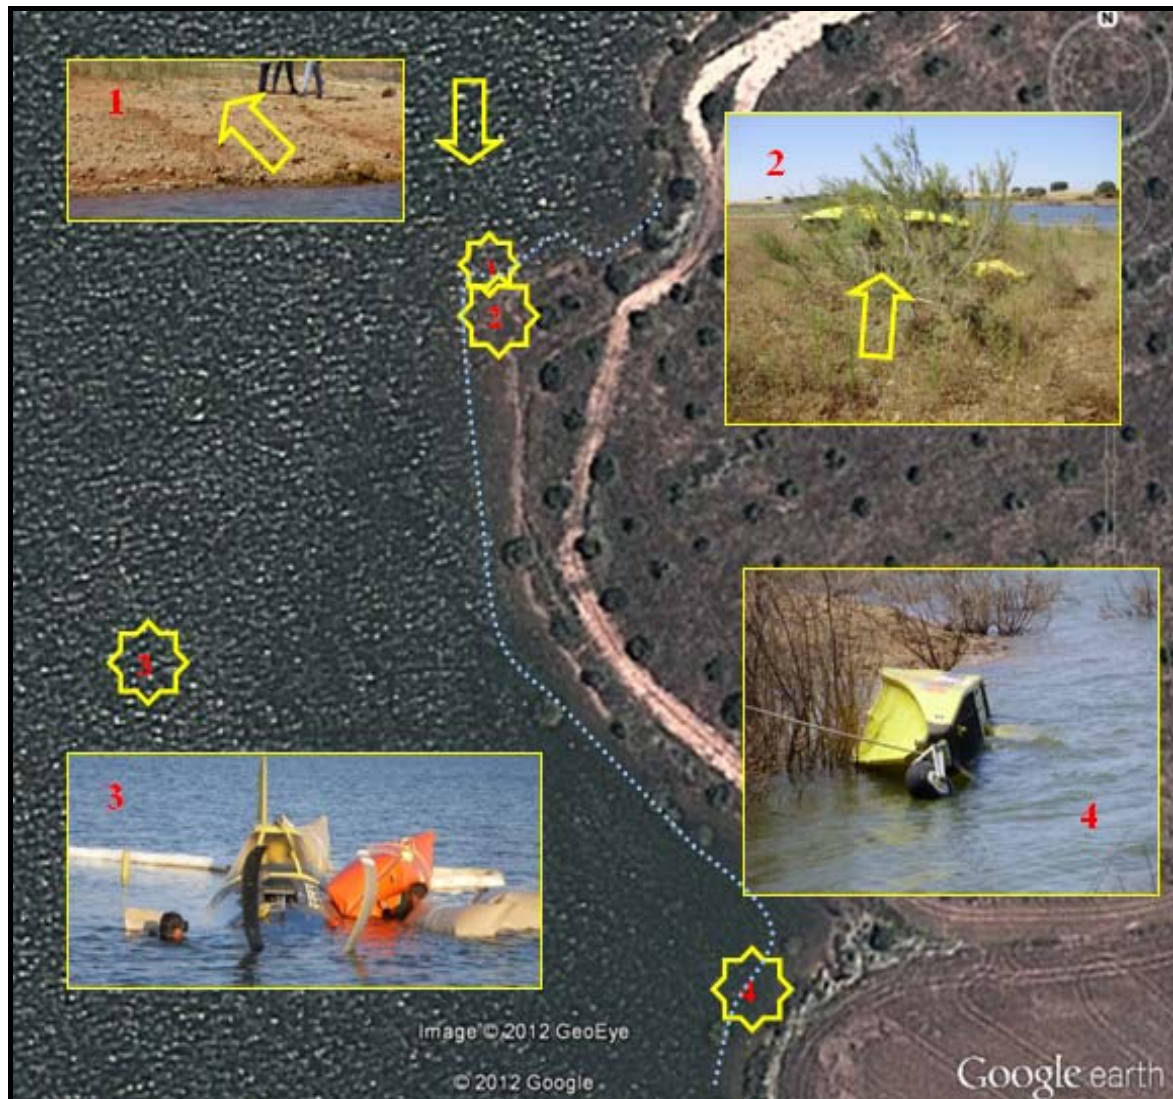
Picture Nr 7

Picture nr 7, bellow, shows ground impact points and wreckage localization, with the arrows pointing on movement direction.

First impact, with both floats, occurred on lagoon water line (1), which was at a bit lower level than the picture shows (more or less by blue dotting line), on a wings levelled and nose up position. Here the left float separated and rested ashore (2), with the aeroplane flying over the neck of land and impacting the water, nose down, a few metres ahead. Without left float, left wing tip impacted the water and outer wing became damaged, while right float broke apart and drift to its final position (4). The aircraft sunk and was later recovered from the bottom (3).

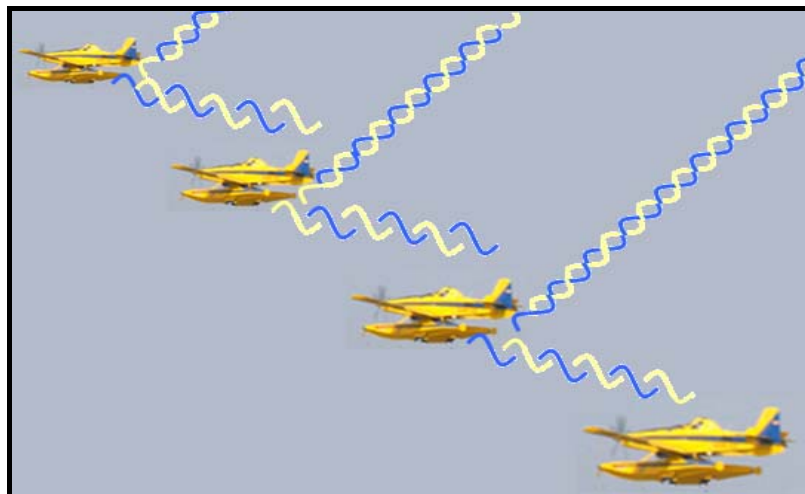
Picture Nr 8

Lateral spacing between aircrafts allowed every aircraft to avoid preceding one (in case of failure and rejected take-off manoeuvre), proceeding in front; while longitudinal spacing kept each aeroplane outside previous aircraft wake, when moving on lake surface (*picture nr 8*).

Under normal conditions, this water wake is not significantly affected by wind direction, especially on still waters, like artificial dam or lakes.

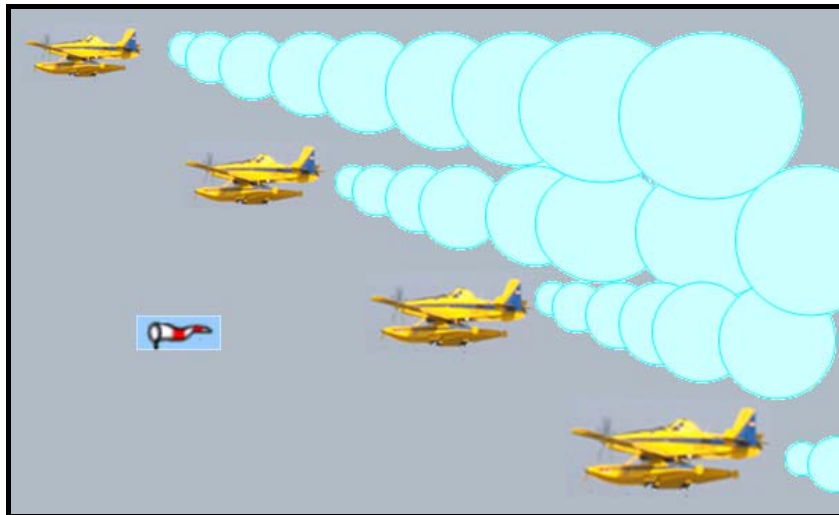
Picture Nr 9

With the planes heading into the wind, wake turbulence waves propagate straight behind and, due lateral separation between aeroplanes, forward aircraft generated turbulence doesn't interfere with following aircraft, which keeps flying undisturbed (*picture nr 9*).

These considerations should have been taken in mind when group leader decided for a group scooping, considering that the best heading for the manoeuvre (265°) was near 45° to the left of prevailing wind direction (310°).

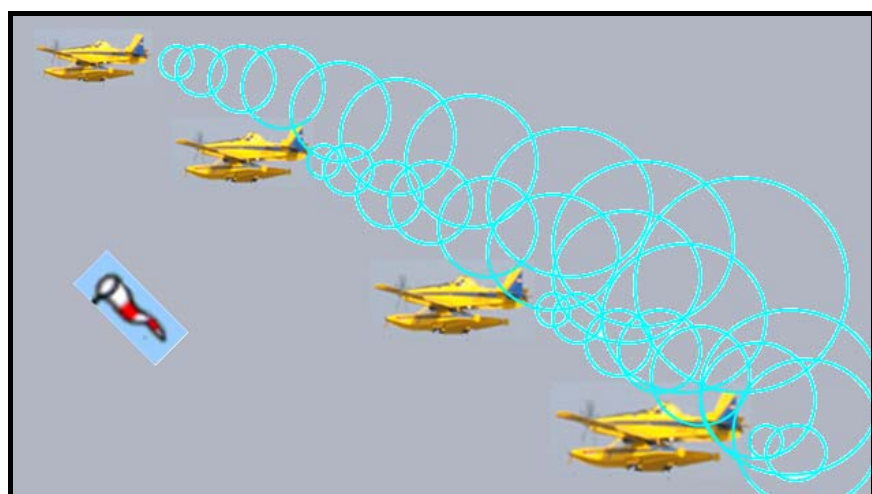
Picture Nr 10

In spite of its low intensity, the wind caused a deviation to the left of wake turbulence waves (*picture nr 10*).

In such a case, wake turbulence generated by preceding aircrafts was interfering with following ones, creating difficulties for its controllability.

If aircrafts 2 and 3 were not too much affected by turbulence and pilots managed to control them without problems, aircraft nr 4 was suffering the influence of all other aircrafts generated turbulence, having its pilot a great difficulty to control the aircraft. In fact, at rotation, after scooping, he lost control of the aircraft and, when he regained it, the aircraft was pointing about 45° to the left, against the margin. He couldn't lift-off before impacting the ground with both floats, lost one of them and crashed a few meters ahead.

If the leader had adopted a right line formation, wake turbulence waves would move outwards of the subsequent aircrafts and the manoeuvre would be facilitated.

“To study the introduction, on his Operations Manual, of more detailed information regarding lateral wind effects on aircraft’s performance and control during group scooping manoeuvres, or other similar operations (like simultaneous take-off and landing manoeuvres) suggesting the use of required procedures, namely different formation layout, in order to minimize or avoid such negative effects” (SR 05/2012)
