NOTICE OF AIRCRAFT INCIDENT

PROCESS Nr: 02/INCID/2013			
Date/Time (UTC ¹): 02-03-2013 / 21:10		Local: Ponta Delgada (LPPD), Azores	
Aircraft	Type: A-310	Registration: CS-TGU	Serial Nr: 571
Operator	SATA International		
Origin/Destination	Lisboa (LPPT) / Ponta Delgada (LPPD)		
People on board	125		
Injuries	Crew	Passengers	Others
Fatal	0	0	0
Serious	0	0	0
Minor / None	8	117	
Aircraft damage: Light

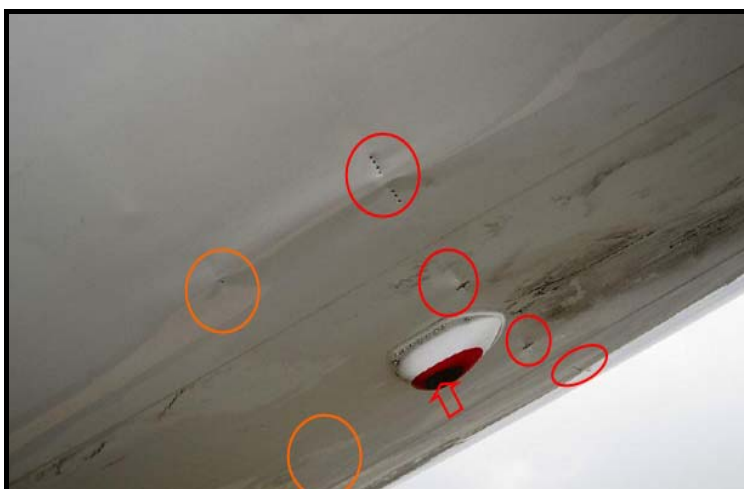
Picture Nr 1

During landing manoeuvre, aircraft attitude was taken to a high angle of nose up and the tail contacted the runway surface.

A primary inspection to the aircraft tail showed some buckling (picture nr 1 – orange circles), a significant tail skid detrition (red arrow) and skin tears (red circles) on pulled rivets zone.

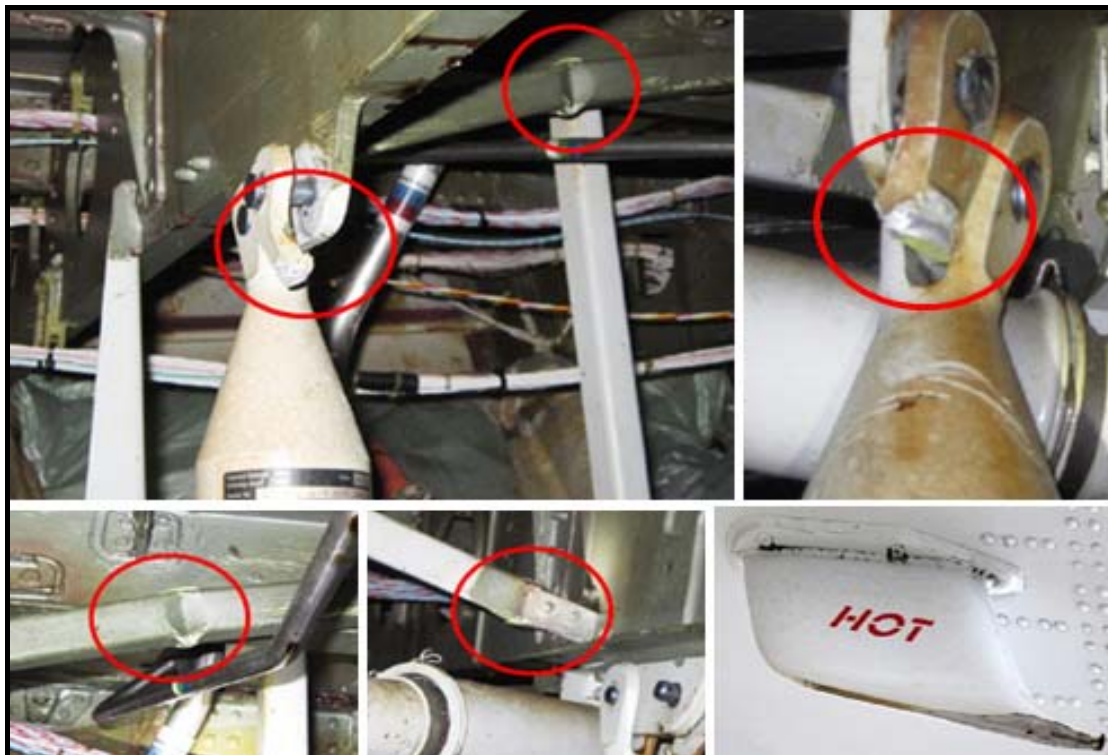
Picture Nr 2

A more detailed inspection found some drain masts bent and worn by contact with runway surface and internal structure with buckled beams and, at frame 77, diagonal strut sheared and vertical struts bent (*picture nr 2*).
