**Accident/Incident:** NLG Collapse after push back - LXR MSN 221

**Airbus Answer to Safety Recommendation Ref:** 01

**TITLE : LANDING GEAR - NORMAL EXTENSION AND RETRACTION - INSPECTION OF THE SELECTOR VALVES 40GA AND 41GA**

### **TITLE: LANDING GEAR-NORMAL EXTENSION AND RETRACTION- INTRODUCE NEW SEAL FOR NLG/MLG DOOR AND GEAR SELECTOR VALVES**

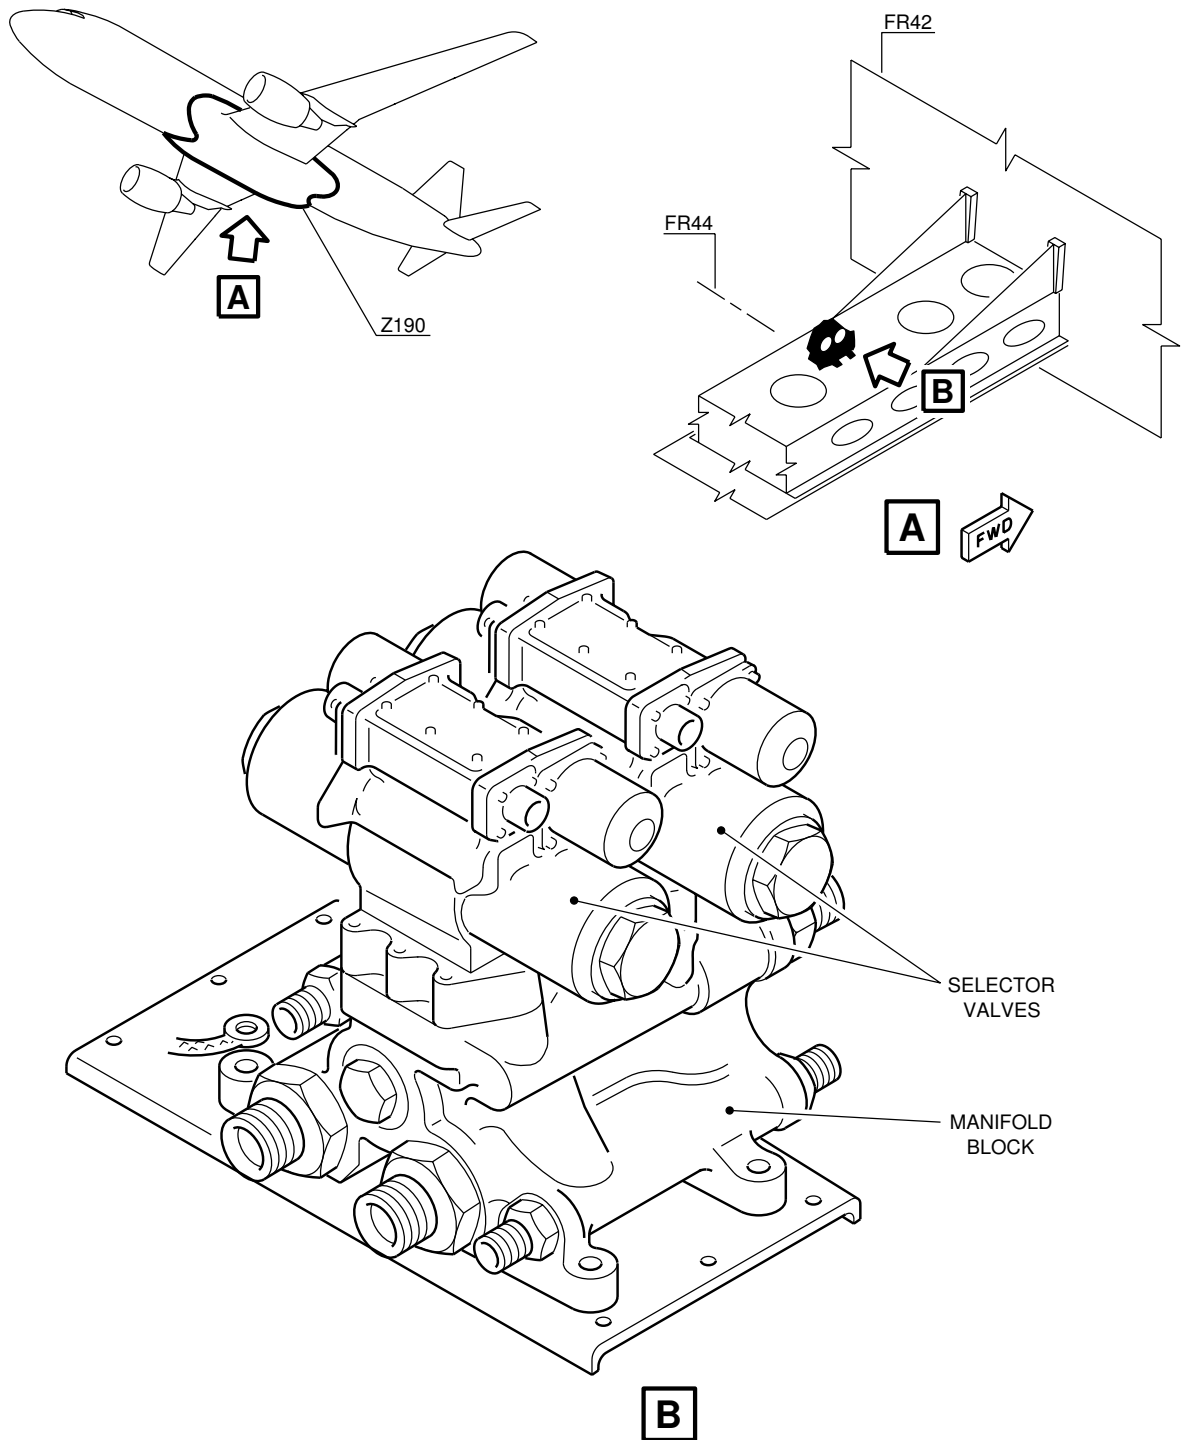
Figure A-USUXX - Sheet 01  
- Selector Manifold Assembly

An internal seal was found damaged leading to an internal leakage that caused the spool of the selector valve to move to the LG retract position. This applied pressure to the retraction and unlock actuator lines, which when coupled with an LGCIU power interrupt, resulted in an uncommanded retraction of the NLG on the ground.

This Service Bulletin introduces GE Aviation Service Bulletin No. 200-32-535. This GE Aviation Service Bulletin introduces new CX seals which are more reliable and less prone to damage.

The mandatory Inspection Service Bulletin A320-32-1290, for the gear and door selector valve inspection, will not be required if both of the valves have been modified on the selector manifold assembly. The Inspection Service Bulletin A320-32-1290 will be applicable if a Pre-Modification valve is fitted to a Post-modification selector manifold assembly.
