***Tail strike landing on runway 30
João Paulo II Airport
Ponta Delgada, Azores
2nd of March 2013, 21:10 UTC
Airbus 310-300***

GPIAA SAFETY REPORT

02/ACCID/2013

FINAL

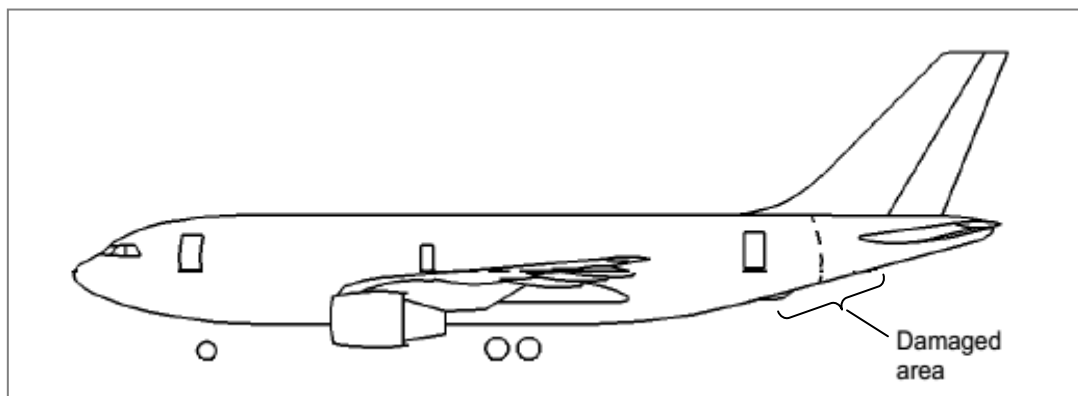
On the preliminary inspection and in accordance with Aircraft Maintenance Manual (AMM 05-51-11 & AMM 05-51-21) the aircraft revealed serious damage³ to the underside of the rear fuselage (Picture nº1), where the lower skin panels were abraded by contact with the runway surface (Photos nº2, 3). In some areas, the skin was buckled through its full thickness and some vertical struts bent the attachment area in the airframe structure (Photo nº4).

Picture n.º1: Skin abrasion

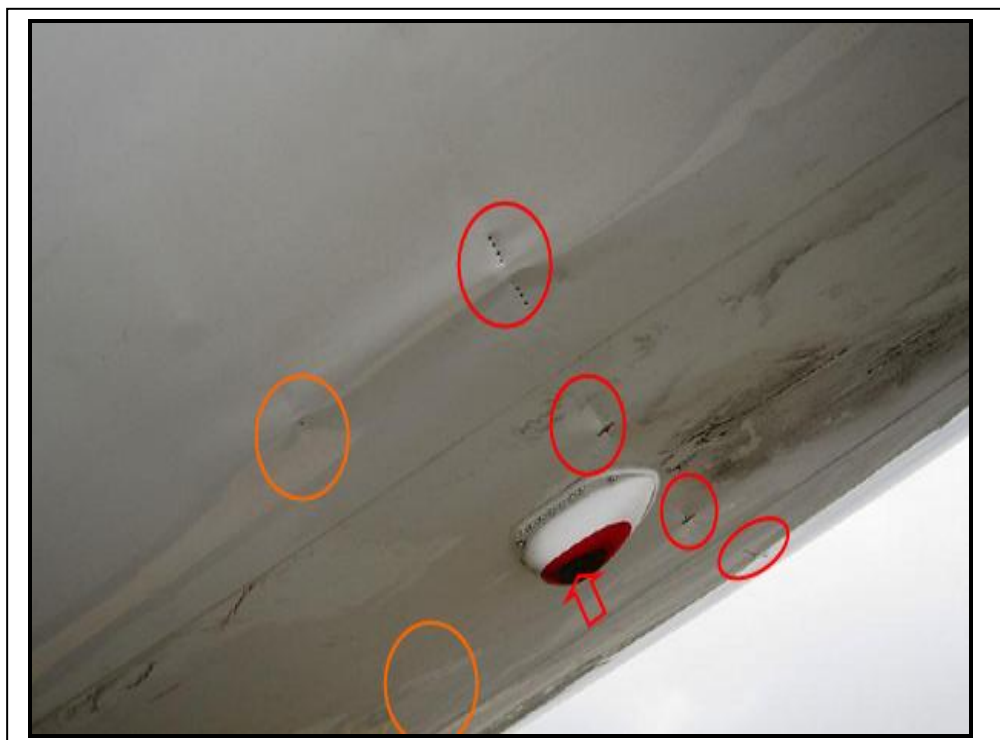
- Tail skid wear;
- GaleY Drain Mast, forward of Fr 80/82, worn and buckled due to runway contact;
- Fuselage tail section Drain Mast, after of Fr 80/82, worn due to runway contact;
- Fr 77 diagonal struts sheared and vertical struts bent at the attachment area with Fr 77 crossbeam;
- Fr 77 crossbeam buckled at struts attachment area (bent afterwards);
- Fr 77 lower fitting buckled (bent forward with lower flange buckled) at Stgr 48/49 LH & RH;
- Fr 77 shear ties bent at the pulled fastener location referred above;
- Fr 76 shear ties, between Stgr 48/50 LH bent;
- Fr 77 web, at Stgr 42 LH & RH, buckled;
- Struts between Fr 77/78, inboard of Y1137, buckled.

Photo nº2: View of tail skid shoe and surrounding area damage

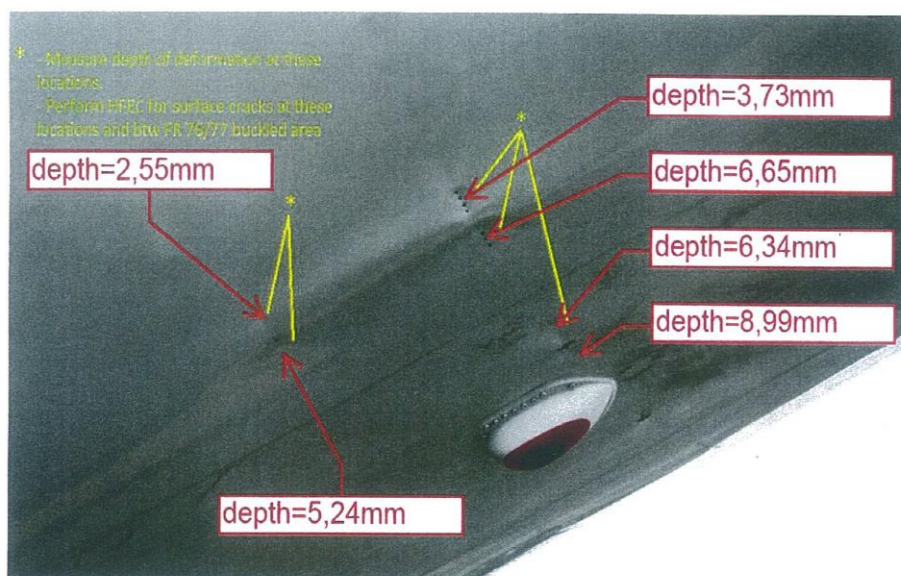
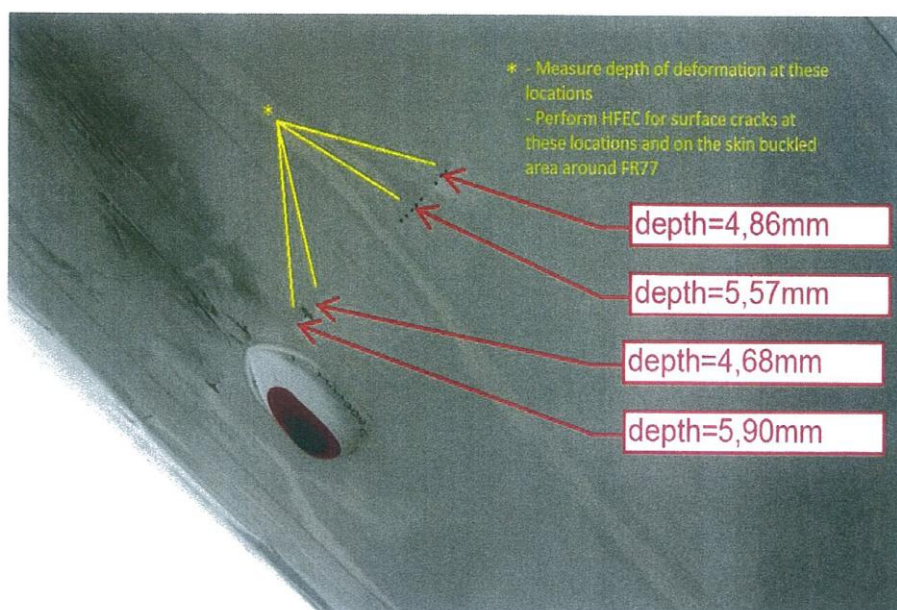
Photo nº3: Detailed analysis of tail skid shoe and surrounding area damage

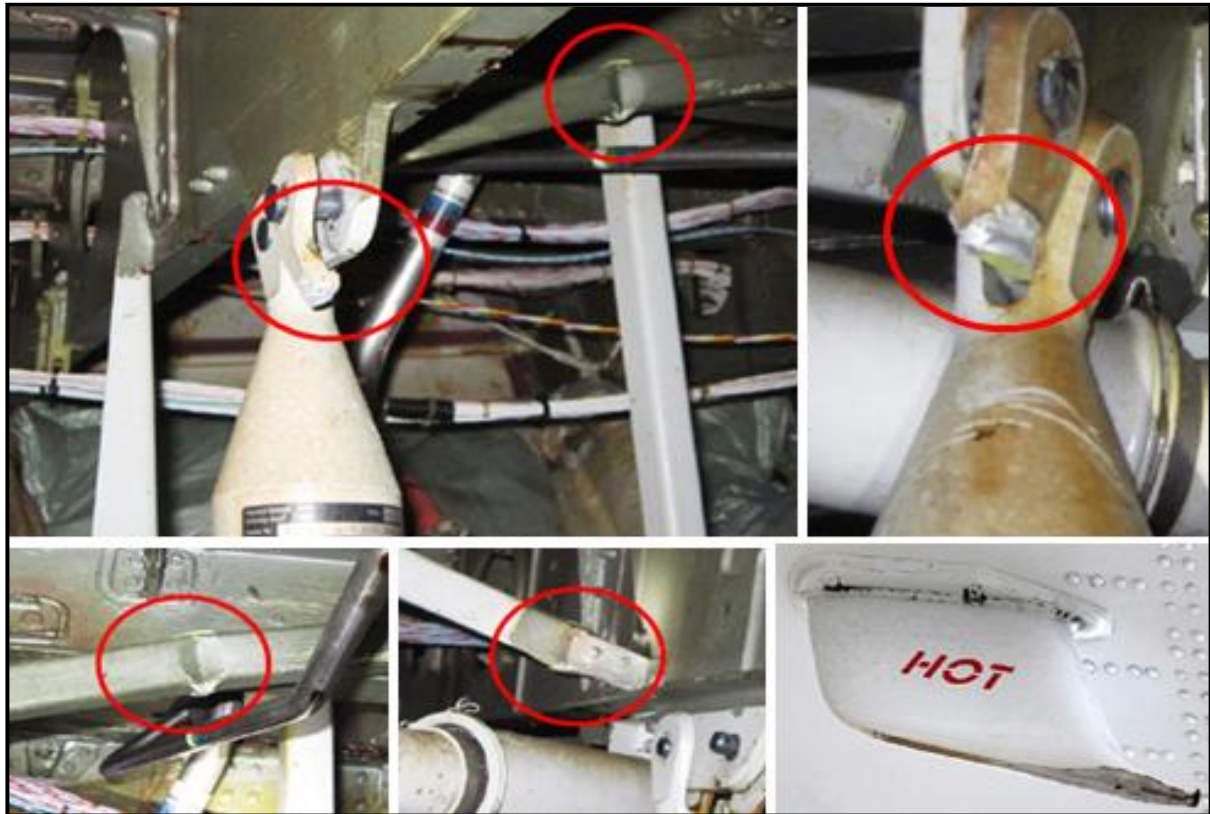
Photo n°4: Tail internal structure damage

Numerous fuselage frames and stringers in the rear fuselage area were damaged by the abrasion and contact forces during the tail strike. The damaged frames were deformed and several were cracked. The diagonal struts sheared and the vertical struts bent at the attachment area with Fr77. Cross beam buckled at struts attachment area (bent in the Aft direction).

DFDR reading confirmed that a firm landing had occurred. According to maintenance personnel the aircraft had sustained damage beyond the structural repair manual, SRM and as a result was grounded for temporary repair at LPPD. The ferry flight to Lisbon for permanent repair took place on the 24/03/2013. The aircraft was released for flight on the 24/05/2013.

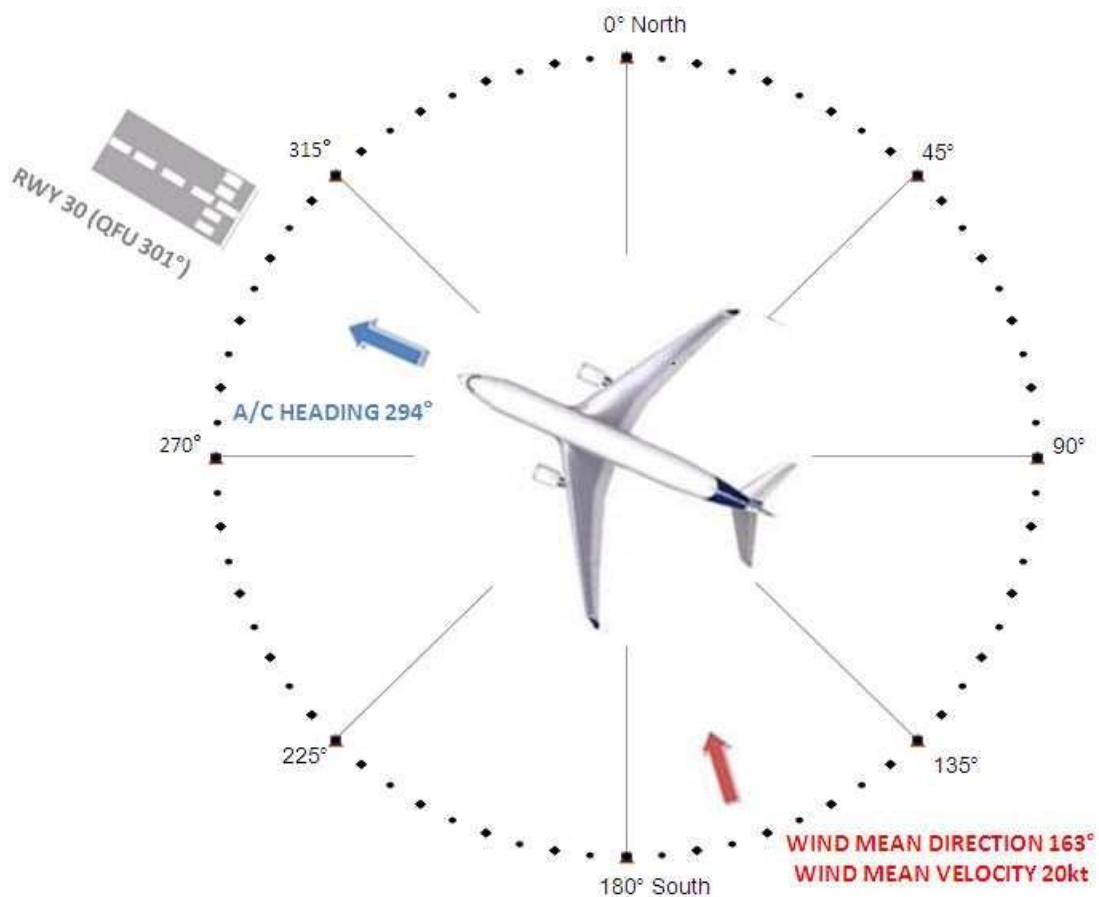
Diagram nº1

Analysis: Wind recorded by DFDR highlights a mean wind direction of 163° at 20kt (tailwind component: 13 kt, left crosswind component: 15kt) consistent with METAR data (170° / 13kt).

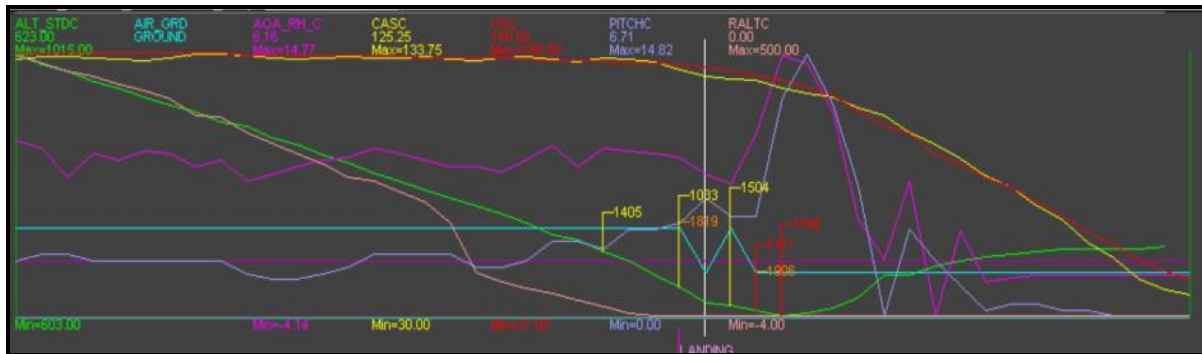
Graph nº3

- ✓ Final app speed was stable at CAS 132kt (Vref+5) and a tailwind component of ≈ 13 kt;

- ✓ At flare starting, there was an increase on vertical acceleration, which caused a short flare and, aided by tailwind, a firm touchdown (1.48 VRTG), with both main landing gears touching down in sequence right than left and signalling spoilers to extend;
- ✓ As aircraft bounced there was an intention to keep the nose up by a “Pull” on the control column most likely to avoid a hard contact of the nose wheel;

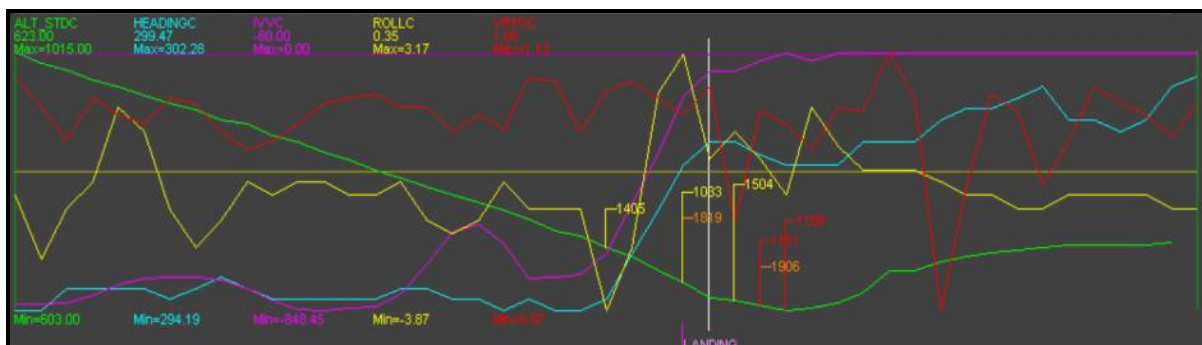
Graph nº4

- ✓ Due to the aircraft bounce, strong tailwind and extension of spoilers there was a natural pitch-up tendency, the force exerted on the control column made the aircraft reach a pitch angle of 14.82°;

- ✓ When the aircraft touched down for the second time and main gear shock absorbers compressed pitch angle exceeded the aircraft's geometry limit for compressed absorbers, making the tail structure strike the ground, as confirmed by "Ground Clearance Diagram" (Diagram n°2), referred on Flight Crew Operating Manual (FCOM) 2.03.22.
