## NOTA INFORMATIVA DE INCIDENTE COM AERONAVE || NOTICE OF AIRCRAFT INCIDENT

<b>PROCESSO    PROCESS 05/INCID/2016</b>			
<b>Data    Date</b> 21/05/2016	<b>Hora    Time (UTC)</b> 08:57	<b>Local    Location</b> Aeroporto de Lisboa - (LPPT)    Lisbon Airport - (LPPT)	
<b>Aeronave    Aircraft</b>	<b>Tipo    Type</b> AIRBUS A320-214	<b>Matrícula    Registration</b> CS-TNP	<b>Número de série    Serial Number</b> 2178
<b>Operador    Operator</b>	TAP Portugal		
<b>Origem / Destino    Origin / Destination</b>	LPPT (Lisboa) / CVSV (São Vicente, Cabo Verde)		
<b>Pessoas a bordo    People on board</b>	6 + 134 (140)		
<b>Lesões    Injuries</b>	<b>Tripulação    Crew</b>	<b>Passageiros    Passengers</b>	<b>Outros    Others</b>
<b>Fatais    Fatal</b>	-	-	-
<b>Graves    Serious</b>	-	-	-
<b>Ligeiras/Nenhumas    Minor/None</b>	6	134	-
<b>Danos na aeronave    Aircraft damage:</b> Substanciais    Substantial

## BREVE DESCRIÇÃO || BRIEF DESCRIPTION

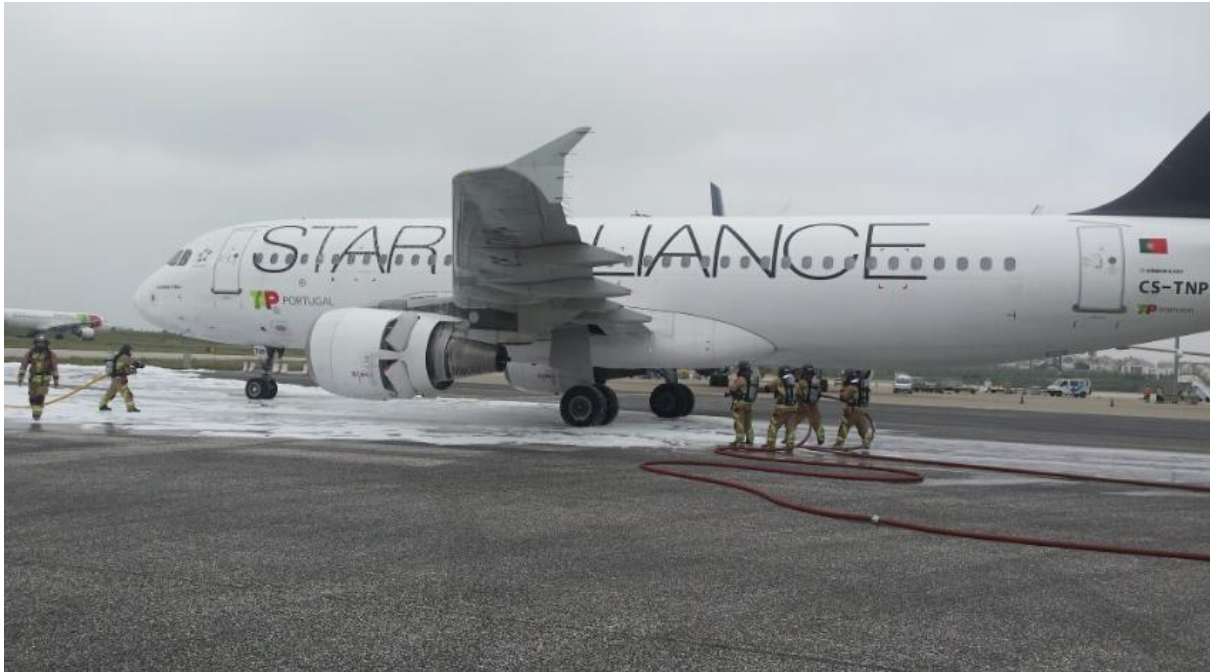
Figura 1 || Figure 1

Aborted take-off was performed at 96 kt due to a loud bang on the left side engine with the consequent loss of CFM56 engine thrust and associated yaw of the aircraft. Maneuvering *RTO* performed with *ECAM ENG # 1 FAIL*.

The aircraft safely decelerated and vacated the runway at position HS, proceeding via *taxiway l*. While rolled to the *Twy L* the control tower informs the crew that the emergency services of the airport had seen flames and smoke coming from the engine # 1.

Although no warning of fire was active in the cockpit, the crew stopped the aircraft and carried out the procedures to shut down the engine with fire and activated the two fire extinguishing bottles installed on the engine.
