## NOTA INFORMATIVA DE ACIDENTE COM AERONAVE AIRCRAFT ACCIDENT NOTICE

<b>PROCESSO GPIAAF    GPIAAF PROCESS ID</b>  <b>07/ACCID/2018</b>		<i>Classificação    Classification</i> <b>Acidente    Accident</b>	
		<i>Tipo de evento    Type of event</i> <b>RE - Runway excursion</b>	
<b>OCORRÊNCIA    OCCURRENCE</b>			
<i>Data    Date</i> 03-OUT-2018	<i>Hora    Time</i> 09:27 UTC	<i>Local    Location</i> Aeródromo Municipal de Torres Vedras, Santa Cruz, Portugal	
<b>AERONAVE    AIRCRAFT</b>			
<i>Tipo    Type</i> Cessna 152		<i>N.º de série    Serial Nr.</i> 152-84658	<i>Matrícula    Registration</i> G-SAYX
<i>Categoria    Category</i> Avião de treino    Training aircraft			<i>Operador    Operator</i> Aeroclube de Portugal
<b>VOO    FLIGHT</b>			
<i>Origem    Origin</i> Cascais - LPCS		<i>Destino    Destination</i> Cascais - LPCS	
<i>Tipo de voo    Type of flight</i> Treino    Training		<i>Tripulação    Crew</i> 01	<i>Passageiros    Passengers</i> 01
<i>Fase do voo    Phase of flight</i> Aterragem    Landing		<i>Condições de luminosidade    Lighting conditions</i> Diurno    Daylight

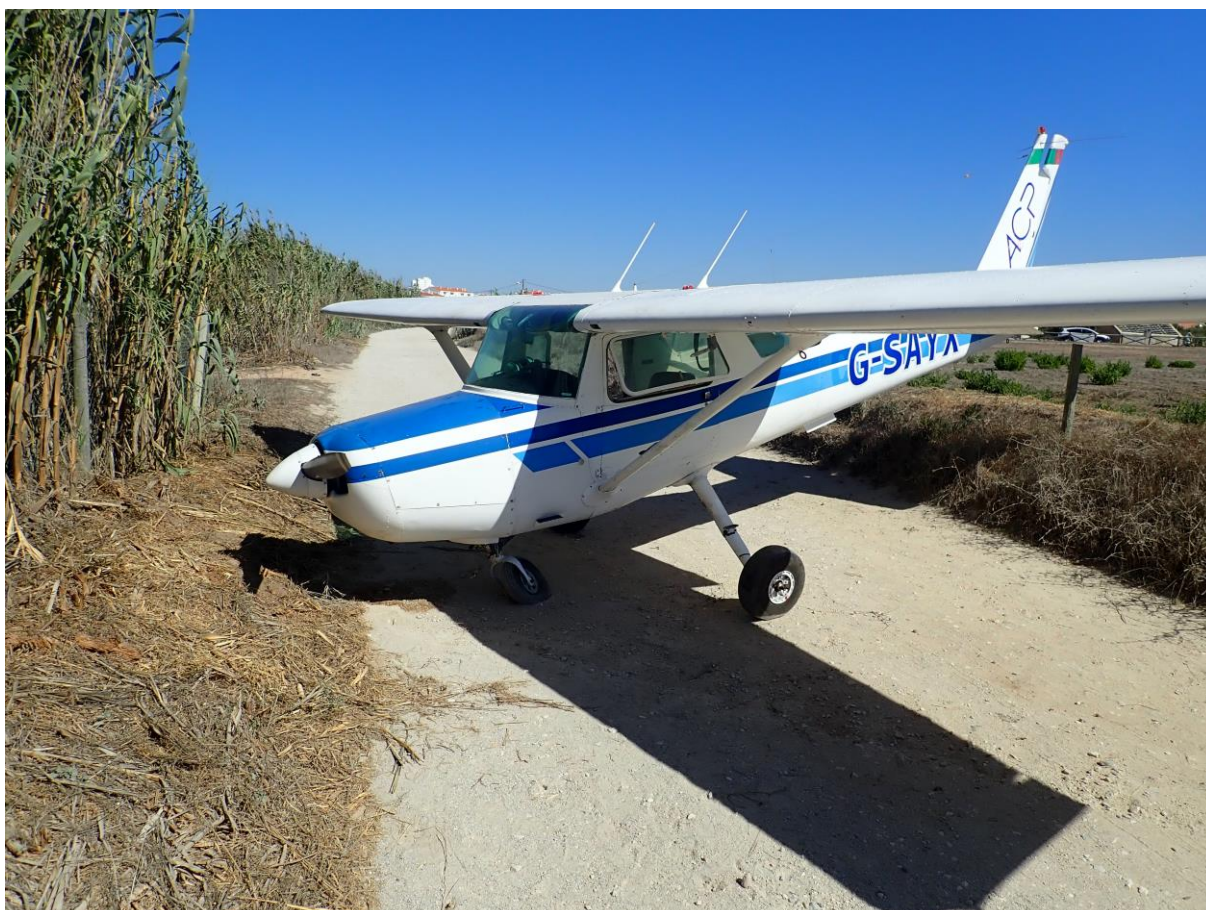
O avião saiu de pista, colapsando o trem de nariz, permitindo que o hélice atingisse o solo.

The aircraft experienced a runway excursion, the nose gear collapsed and the propeller touched the ground.

Posição final da aeronave | Aircraft final position – GPIAAF
