## NOTA INFORMATIVA DE ACIDENTE COM AERONAVE AIRCRAFT ACCIDENT INFORMATION NOTICE

<b>PROCESSO GPIAAF    GPIAAF PROCESS ID</b> <b>2019/AVAL/015</b>		<i>Classificação    Classification</i> Acidente    Accident	
		<i>Tipo de evento    Type of event</i> LOC-I	
<b>OCORRÊNCIA    OCCURRENCE</b>			
<i>Data    Date</i> 03-JUN-2019	<i>Hora    Time</i> 19:15 UTC	<i>Local    Location</i> N40 38.9063 W008 27.1484, Macinhata do Vouga, Aveiro, Portugal	
<b>AERONAVE    AIRCRAFT</b>			
<i>Tipo    Type</i> PMT-G1 (Paramotor com trem de aterragem)		<i>N.º de série    Serial No.</i> Nenhuma    None	<i>Matrícula    Registration</i> Nenhuma    None
<i>Categoria    Category</i> Ultraleve Grupo 1    Group 1 Powered paraglider (PPG)		<i>Operador    Operator</i> Privado    Private	
<b>VOO    FLIGHT</b>			
<i>Origem    Origin</i> Mesa - Macinhata do Vouga		<i>Destino    Destination</i> Mesa - Macinhata do Vouga	
<i>Tipo de voo    Type of flight</i> Voo de ensaio    Test flight		<i>Tripulação    Crew</i> 01	<i>Passageiros    Passengers</i> 01

## BREVE DESCRIÇÃO DA OCORRÊNCIA

## BRIEF DESCRIPTION OF THE OCCURRENCE

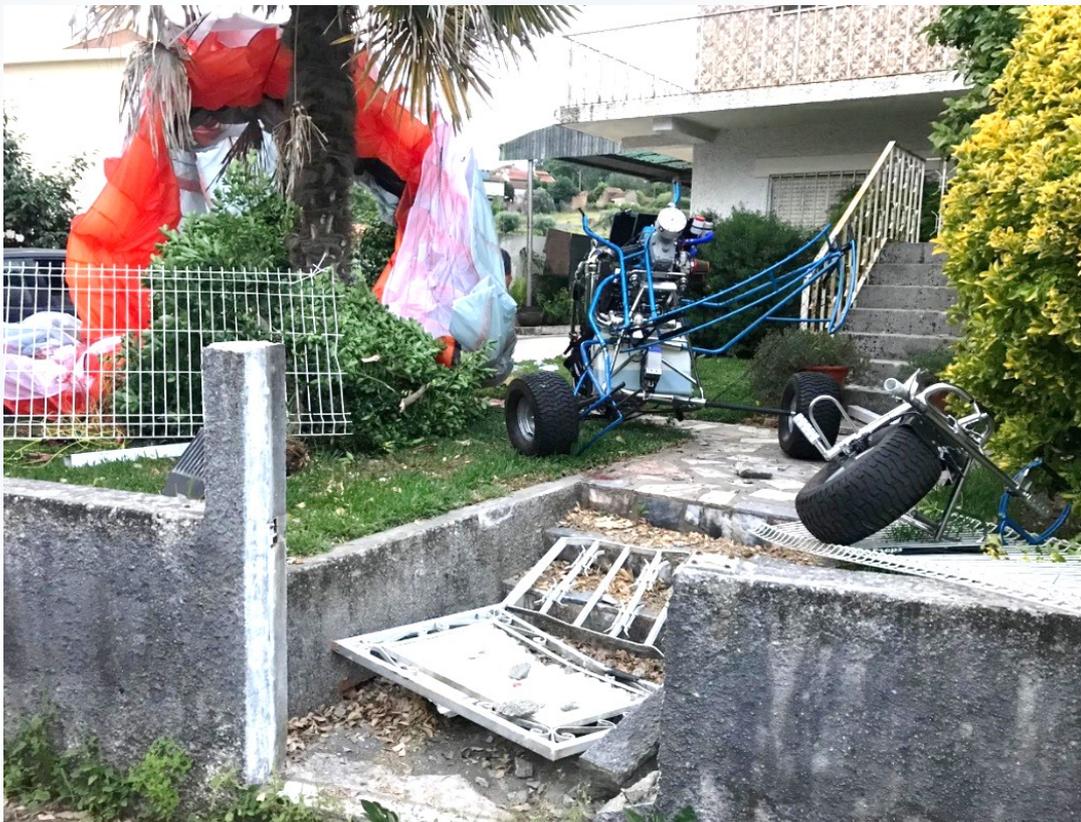
A trajetória descendente terminou com o embate frontal da aeronave na vedação de uma vivenda na povoação de Macinhata do Vouga.

The downward trajectory ended with the frontal aircraft crash into the fence of a house in the village of Macinhata do Vouga.

Figura 1 || Figure 1 Foto || Photo: GNR Destacamento Territorial de Águeda  
Posição final da aeronave || Aircraft final position

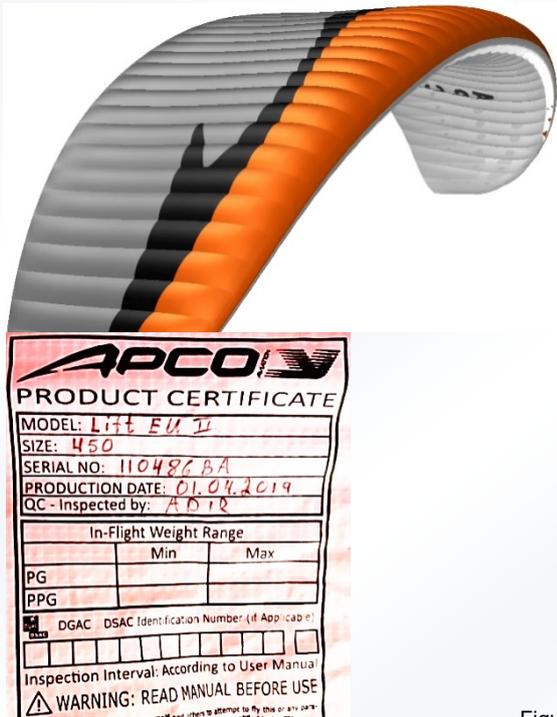
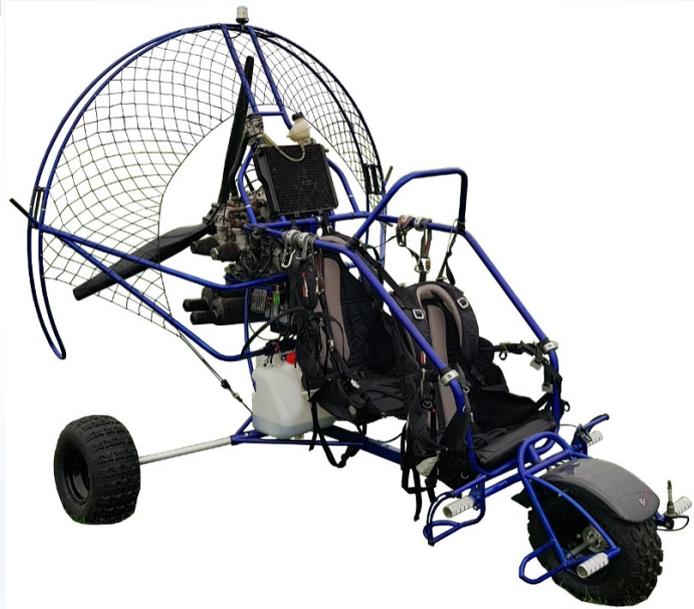
A aeronave é constituída por um *trike* de produção local com designação hscom, modelo Condor XL Paratrike, e por uma asa marca APCO modelo LIFT EU II 450 utilizada em *trikes* pesados equipada com trações manuais aerodinâmicos.

The aircraft using a local manufactured trike, branded hscom, model Condor XL Paratrike and a wing APCO model LIFT EU II 450 for European medium to heavy trikes (with narrow hook-in points and hand held brakes).

The aircraft did not evidence to comply with the minimum and internationally accepted ASTM (*American Society for Testing and Materials*) standards, namely the F2563-16 (Standard Practices for kit assembly instructions of aircraft intended primarily for recreation), and the F2242-05 (Standard specification for production acceptance testing system for powered parachute aircraft).

Figura 2 || Figure 2  
 Detalhe do equipamento acidentado || Accident equipment detail
