EMBRAER E190-100LR

AIR ASTANA / P4-KCJ

ACCIDENT  
SAFETY INVESTIGATION  
FINAL REPORT

[08/ACCID/2018]

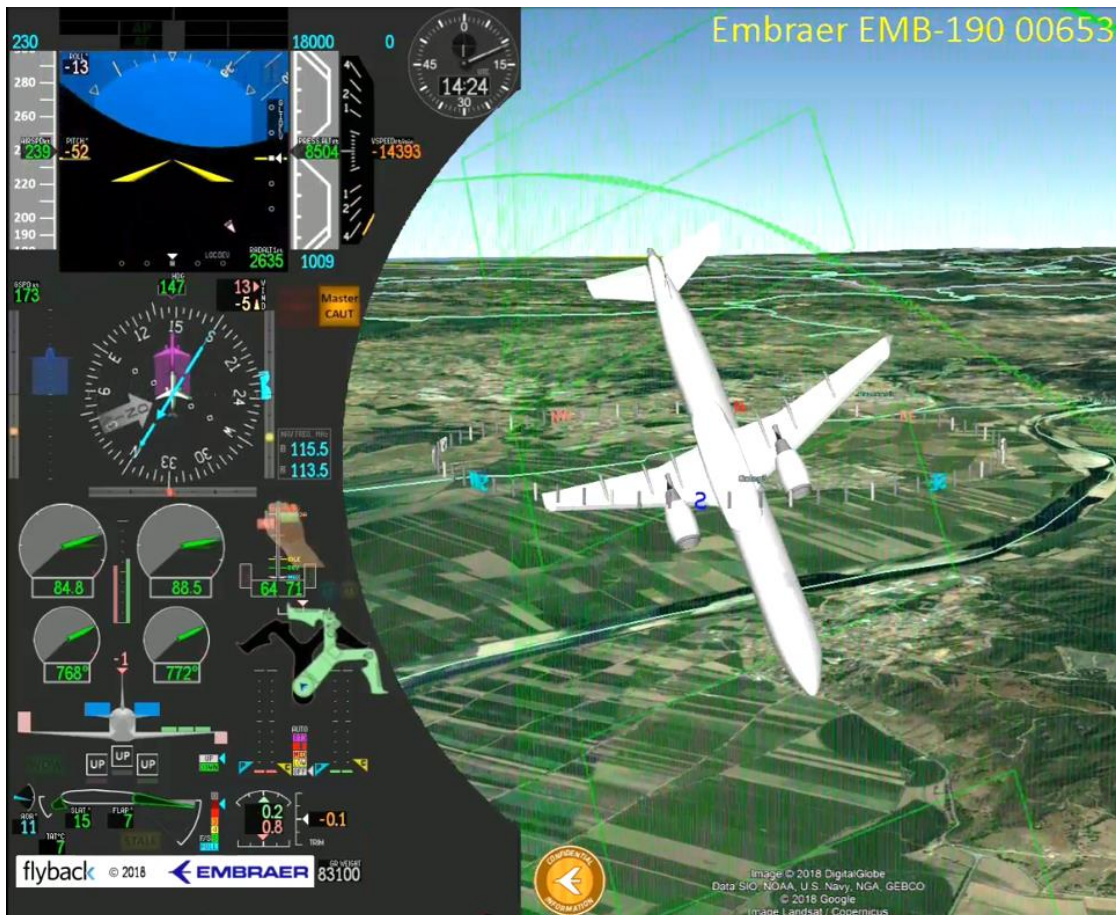
Figura 2

Atitude anormal da aeronave – Exemplo FDR  
 Fonte: flyback Embraer

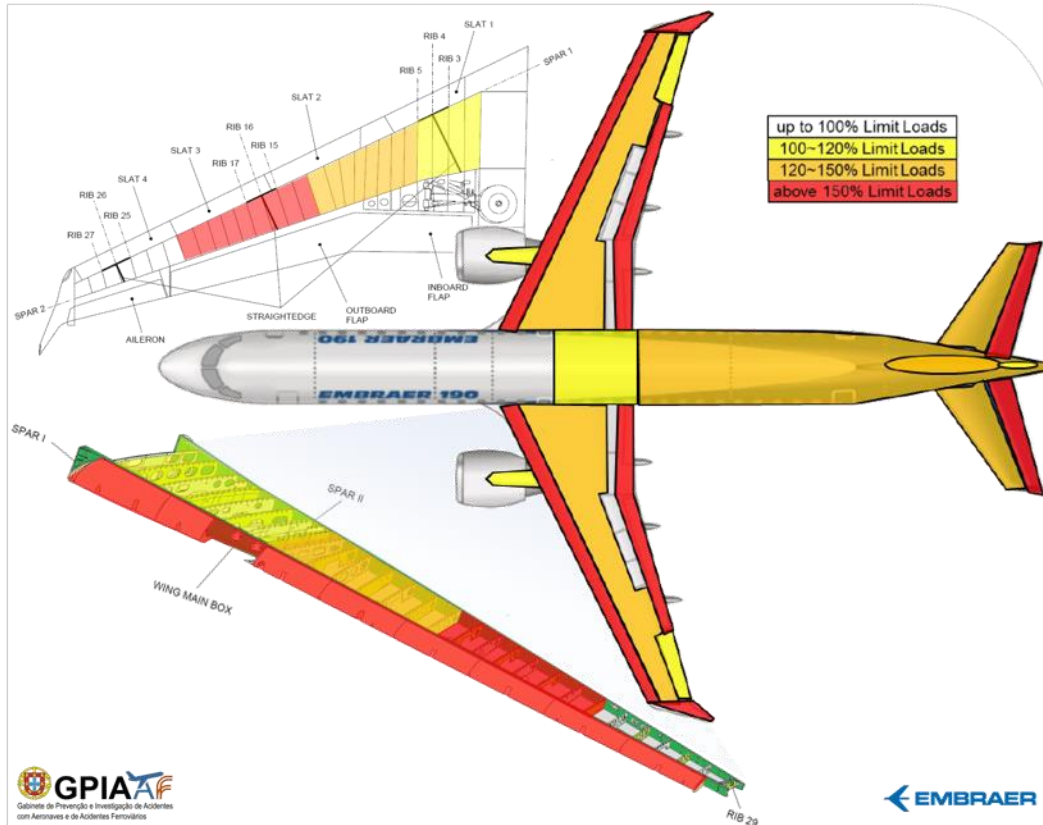
Figura 4 || Figure 4

All wing fixed leading edges were found wrinkled. The damage geometry was found sharper on forward and aft regions, and smoother on inboard and outboard regions, indicating that the damage was caused by wing bending around the wing chord direction.

Áreas da aeronave afetadas e cargas limite aplicadas durante o voo do evento

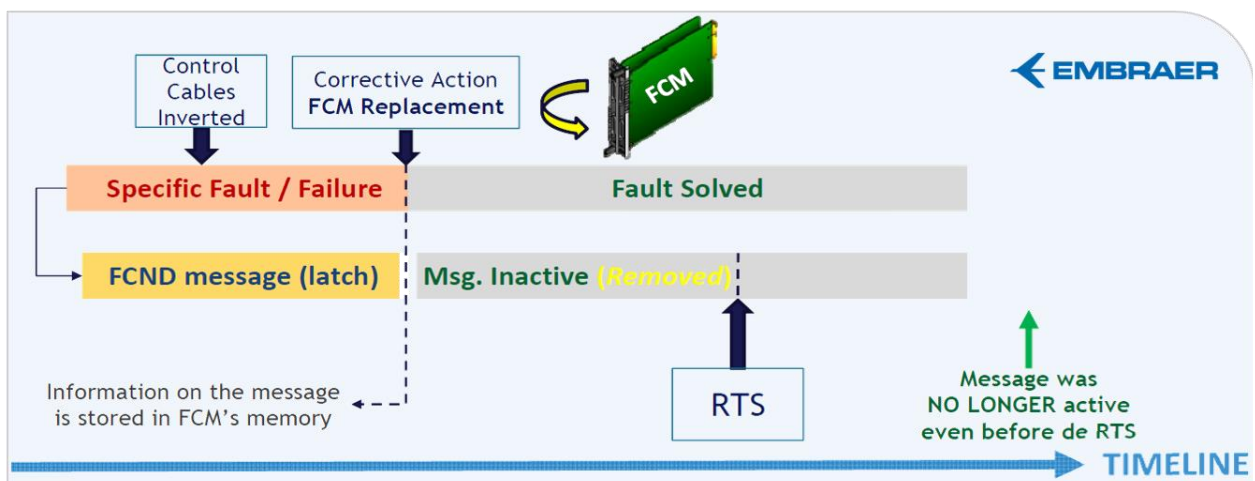
Figura 15 || Figure 15

Having the same pre-conditions of test #3 with the inverted aileron control cables and after performing the corrective actions that latched the FCND message, the related FCM was replaced by an FCM with a cleared NVM and the RTS performed. The FCND was no longer active, even before performing the RTS.

Sequência de ações e resultados do teste #4 || Test #4 event sequence and findings

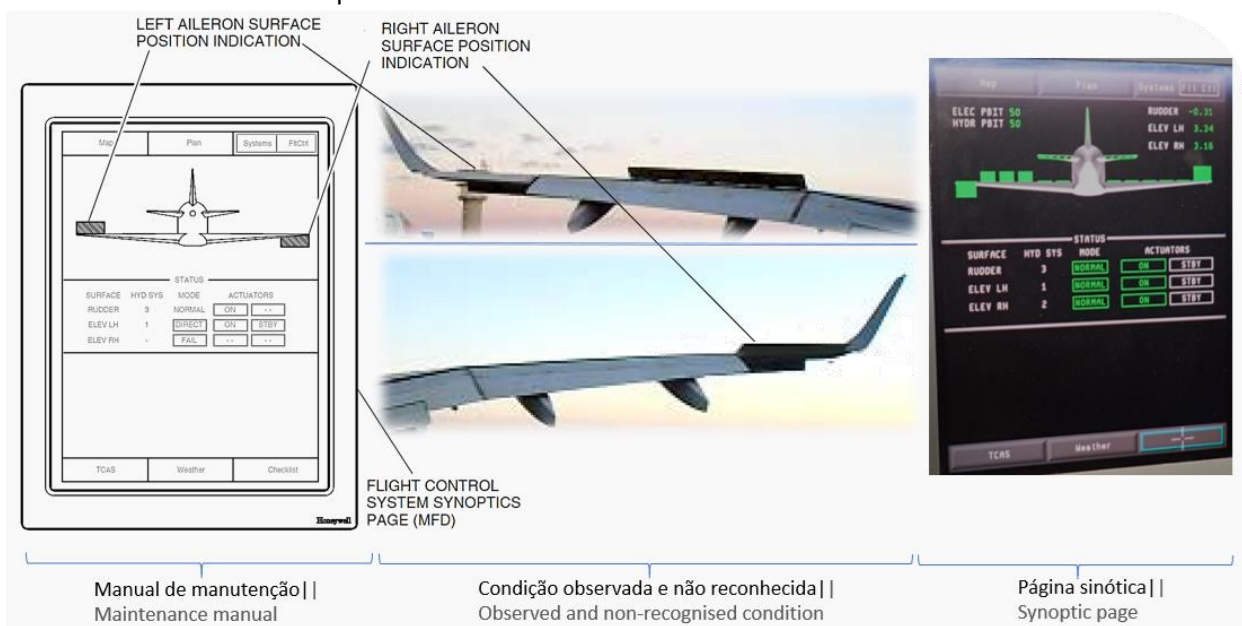
Figura 16 || Figure 16

As the aircraft was in this configuration without applied power, the operational tests to check the ailerons correct operation were not immediately performed after completing the cable replacement task, as required in the SB.

After the aircraft power-up and during the operational checks, a FLT CTRL NO DISPATCH was triggered due to a failure in the FCS. However, due to the non-detected aileron control cables inversion, it was not possible to fully perform the reset cycle on the flight controls return to service procedure, exercising the five CBIT of the ailerons control systems and cleaning the NVMs on the FCMs.

Ilustração da posição física dos *ailerons*, conforme tarefa de manutenção à data do evento

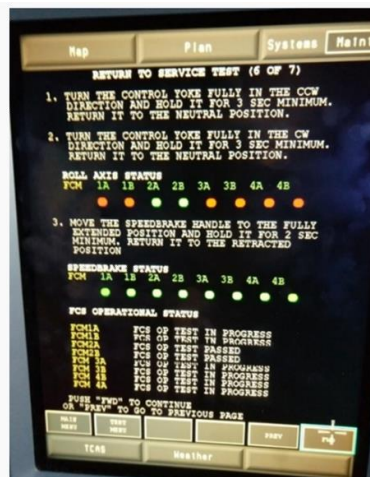
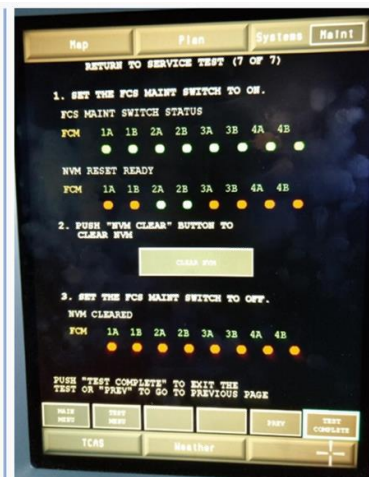
Figura 17

After six power-down/power-up sequences, the FLT CTR NO DISPATCH message did not reappear following the flight controls system return to service (RTS) procedure.

Ilustração do teste dos FCM e condição das respetivas NVMs antes do voo do acidente

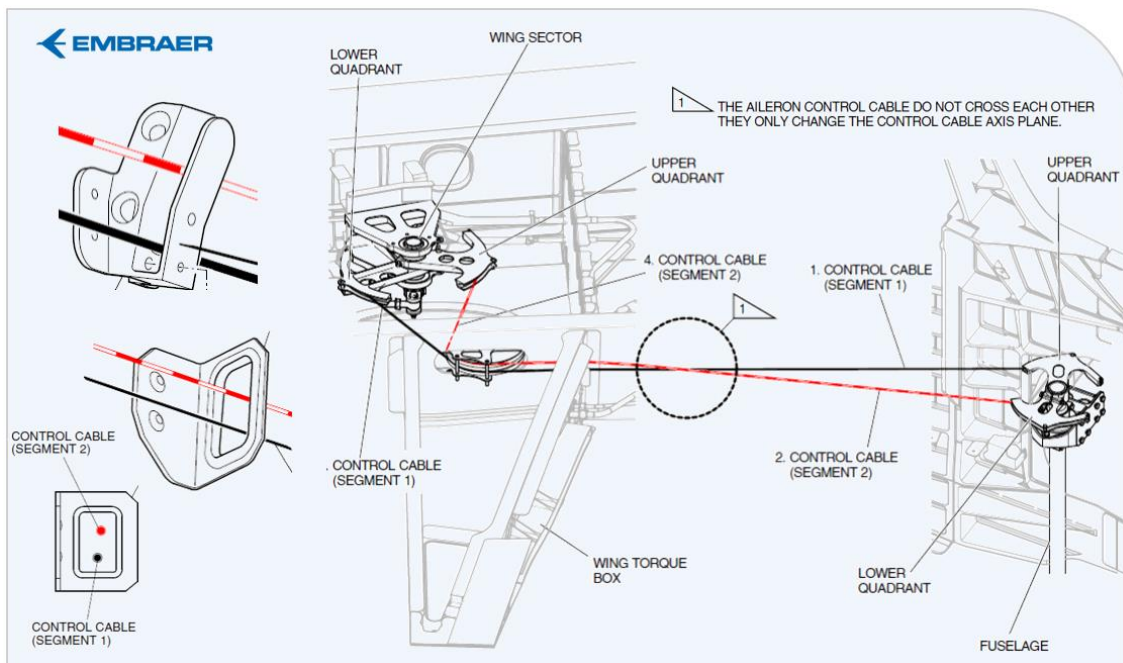
**Figura 19**  
 Figura exemplificativa das alterações preconizadas na tarefa de manutenção de substituição dos cabos  
 Fonte – AMM 27-11-03 Rev. Out 2019

After the event and during the investigation, the OEM made important changes to the approved instructions and procedures, such as changing aileron control cables replacement task adding clearer instructions and using figure colouring on SB 190-57-0038 aileron control cables - fairleads and grommet replacement related instruction, the SB for cable material replacement and also on the operational task to check the ailerons position.

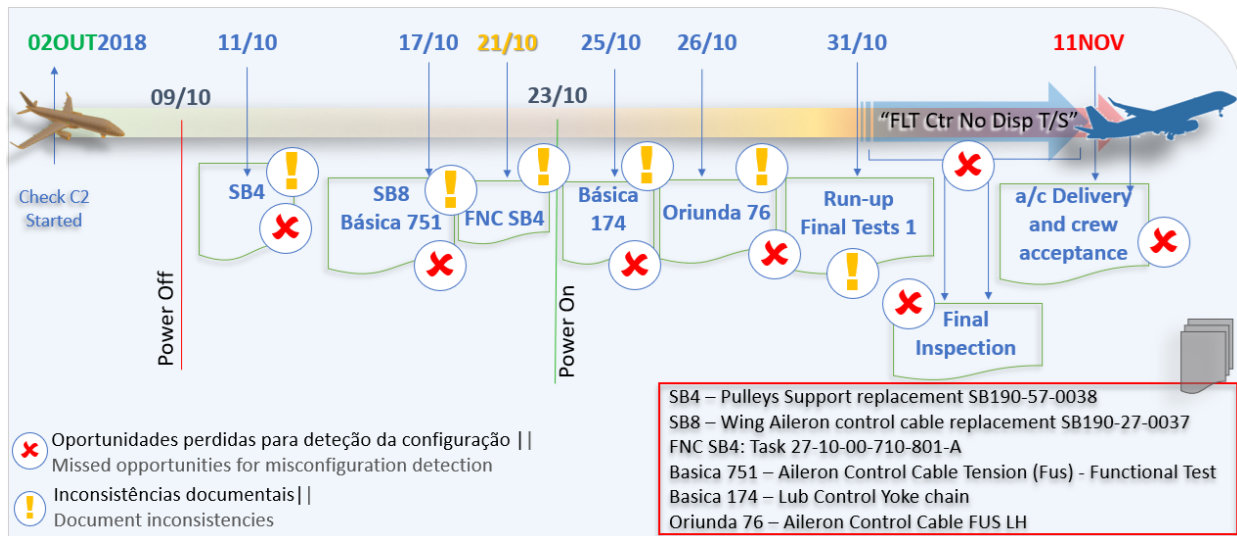
Figura 23 || Figure 23

Sequência de oportunidades perdidas de deteção do erro de configuração

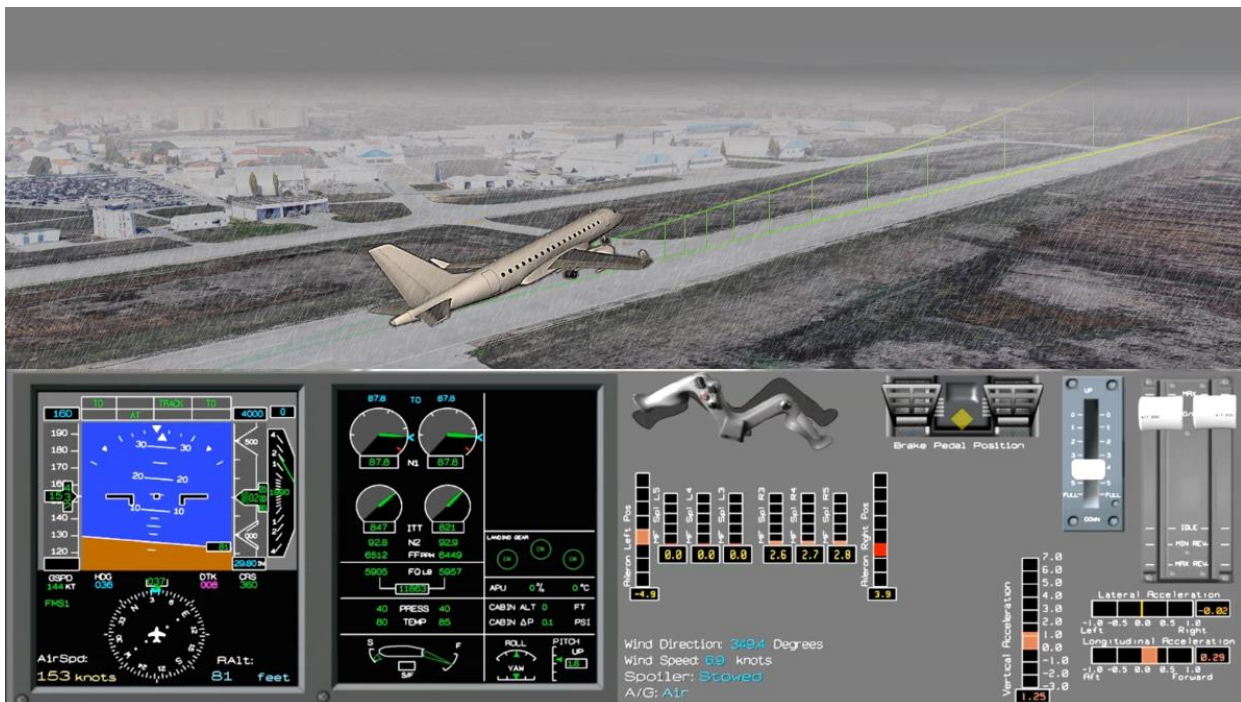
Figura 30

As described in the meteorological factors, the aircraft took off with a low ceiling, forcing the crew to immediately change to instrument flight rules in IMC and the loss of visual references. Not being a mandatory requirement, carrying out this type of flight with minimum VFR conditions would be good practice.

Simulação das condições meteorológicas à decolagem para o primeiro voo após manutenção
