SERIOUS INCIDENT

Aircraft Type and Registration:	Airbus A320-214, G-EZTD	
No & Type of Engines:	2 CFM56-5B4/3 turbofan engines	
Year of Manufacture:	2009 (Serial no: 3909)	
Date & Time (UTC):	24 April 2019 at 2022 hrs	
Location:	Lisbon Airport, Portugal	
Type of Flight:	Commercial Air Transport (Passenger)	
Persons on Board:	Crew - 6	Passengers - 175
Injuries:	Crew - None	Passengers - None
Nature of Damage:	None reported	
Commander's Licence:	Airline Transport Pilot's Licence	
Commander's Age:	27 years	
Commander's Flying Experience:	4,300 hours (of which 4,100 were on type) Last 90 days - 162 hours Last 28 days - 38 hours	
Information Source:	AAIB Field Investigation

Synopsis

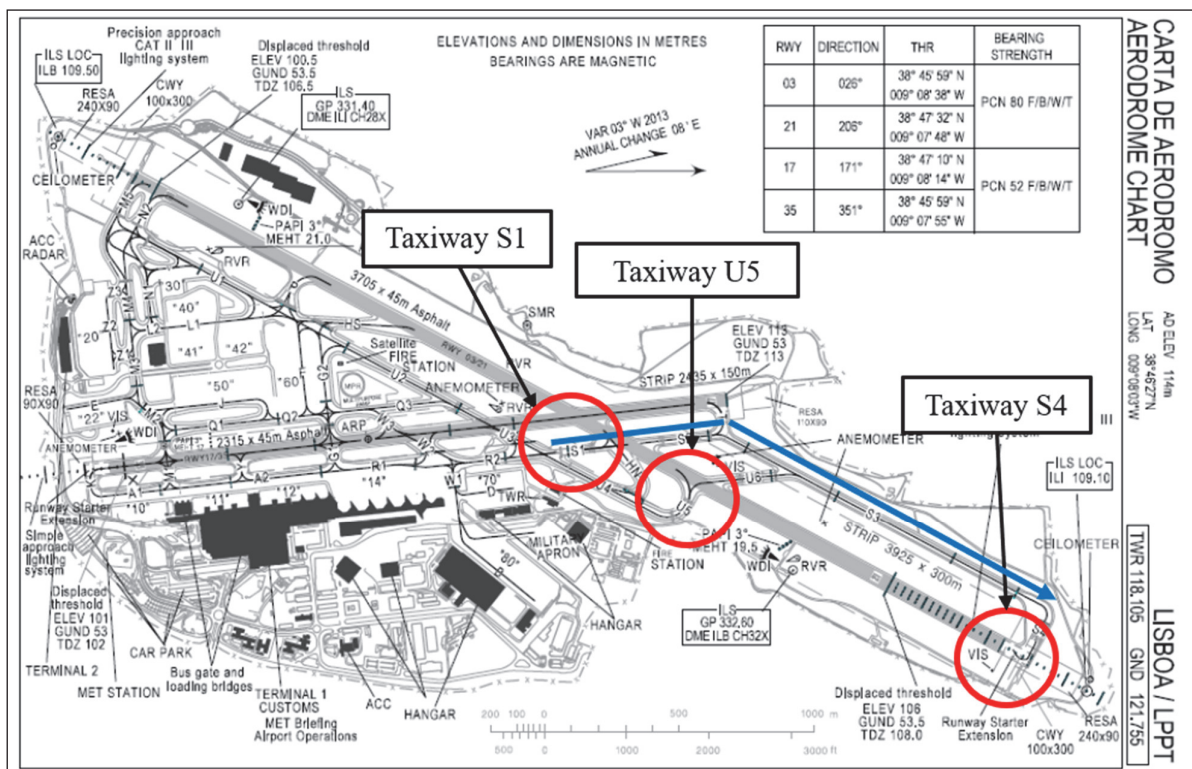
The aircraft was making the return flight to London Luton Airport from Lisbon Airport having arrived at Lisbon at 1940 hrs. The crew initially planned for a departure from the intersection of Taxiway U5 with Runway 21 (Figure 1) and both pilots completed the performance calculations from this intersection (Takeoff Run Available (TORA) 2,410 m). This intersection was referred to as 'PSNUTMP' (temporary position U)¹ in the Electronic Flight Bag (EFB). The crew subsequently re-planned for a departure from Taxiway S1, but in recalculating the performance they both selected 'PSNSTMP' (temporary position S). This position was the intersection of Taxiway S4 with the runway ie the full length of the runway. The crew did not cross check the TORA from PSNSTMP against the TORA from Taxiway S1, so the error was not identified by the crew before takeoff.

on start-up if they require the full length of the runway for takeoff. Full-length departures are from Holding Point S4, which is known as ‘Position S’. Taxiway S begins abeam Runway 17, before crossing Runway 21 at Taxiway S1, and then turning north-east to run parallel to Runway 21 (marked on Figure 1 in blue). The taxiway ends at the threshold of Runway 21. There are therefore two points on Runway 21 where Taxiway S intersects the runway.

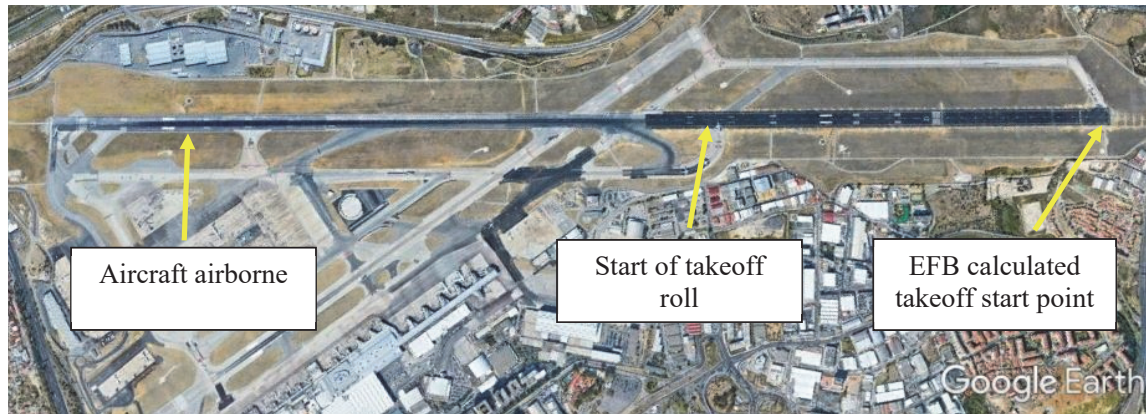
Figure 2

The aircraft departed from the Taxiway U5 intersection (TORA 2,410 m) at 2034 hrs using an engine thrust setting based on performance figures calculated for the full length of the runway (TORA 3,805 m) (Figure 2). With the reduced power setting, the commander commented subsequently that the takeoff "felt wrong", but Takeoff/Go-around (TOGA) thrust was not selected. The aircraft passed the upwind threshold of the runway at a height of approximately 100 ft. During the flight, the crew realised what had happened and reported it to the operator after landing.

Image of Lisbon Airport showing the calculated and actual takeoff points

Analysis of the FDR data for the event showed that the takeoff roll was about 1,860 m long, with the aircraft becoming airborne 400 m before the upwind runway threshold, which it overflew at 100 ft climbing at about 2,700 ft/min. The airspeed at lift off was 170 KIAS.

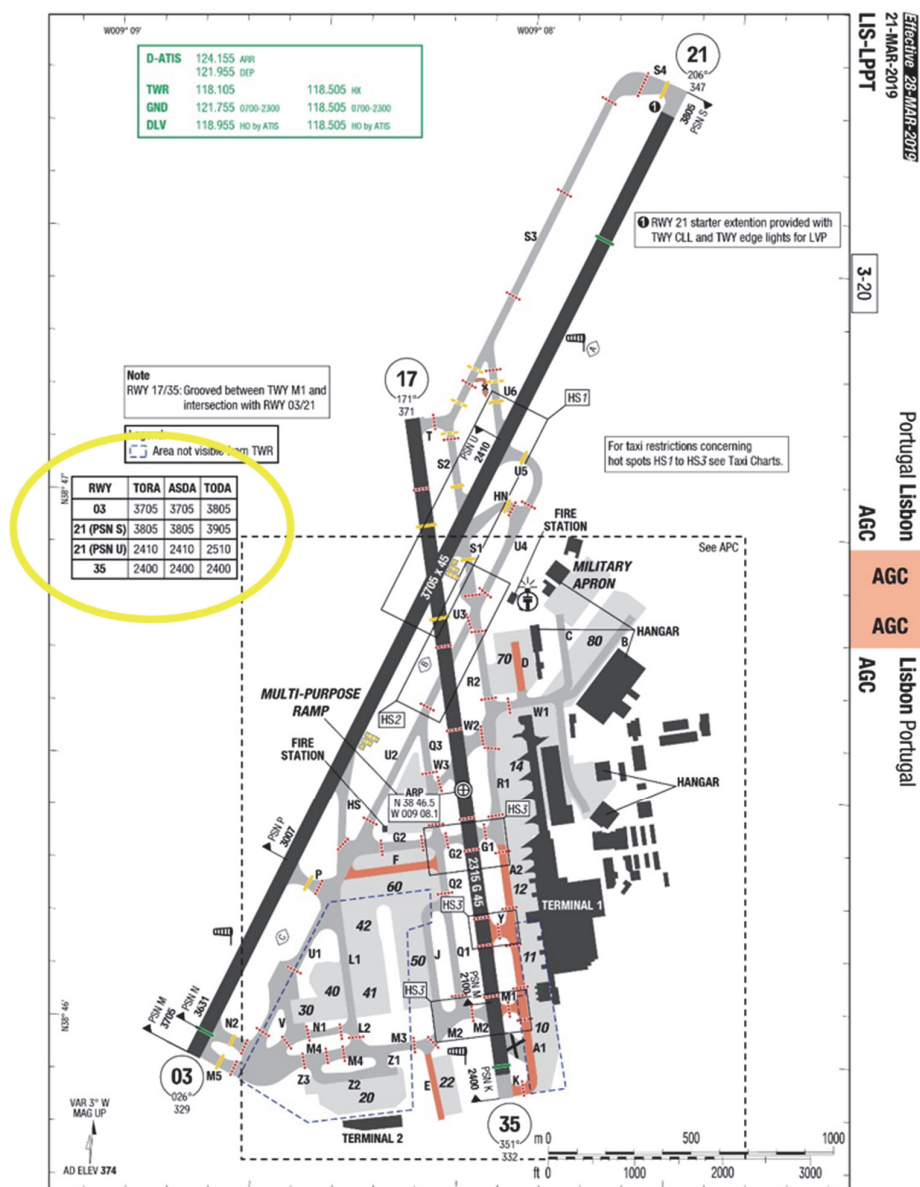
Lisbon Airport has two runways which are orientated 03/21 and 17/35 as shown in Figures 1 and 3. Runway 03/21 is the preferred runway for both takeoffs and landings, and the prevailing winds mean that Runway 03 is more commonly used. At the time of publication, Runway 17/35 was expected to close and become a taxiway.

Lisbon aerodrome ground chart © LIDO

Both pilots are required to cross-check the runway distances available from the chosen intersection against the lengths displayed on the aerodrome ground chart, as shown circled in yellow in Figure 3 for Lisbon.
