NOTA INFORMATIVA DE INCIDENTE COM AERONAVE AIRCRAFT INCIDENT INFORMATION NOTICE

PROCESSO GPIAAF // GPIAAF PROCESS ID 2021/AVAL/01		Classificação // Classification Incidente // Incident	
		Tipo de evento // Type of event SFC-PP: Falha ou mau funcionamento do grupo motopropulsor // Powerplant failure or malfunction	
OCORRÊNCIA // OCCURRENCE			
Data // Date 05-01-2021	Hora // Time 11:35 UTC	Local // Location VANUP point (LPST) Sintra, Portugal	
AERONAVE // AIRCRAFT			
Tipo // Type Tecnam P2006T		N.º de série // Serial No. 046	Matrícula // Registration CS-EAQ
Categoria // Category Aviação Geral // GA		Operador // Operator Sevenair Academy	
VOO // FLIGHT			
Origem // Origin LPCS – Cascais		Destino // Destination LPCS – Cascais	
Tipo de voo // Type of flight Voo treino local // Local training		Tripulação // Crew 02	Passageiros // Passengers 00
Fase do voo // Phase of flight Manobra // Manoeuvring		Condições de luminosidade // Lighting conditions Diurno // Daylight	
CONSEQUÊNCIAS // CONSEQUENCES

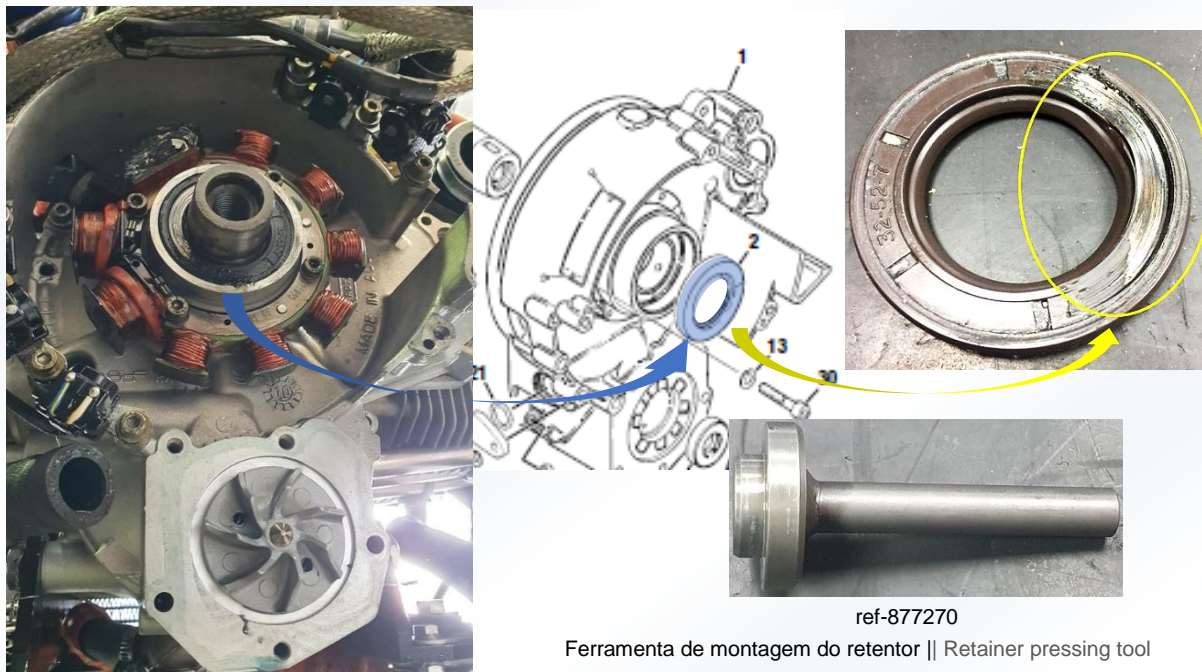
Figura 1 || Figure 1

Durante a avaliação e ensaio ao motor verificou-se que a fuga estaria na “Ignition Housing”, que após desmontagem, foi encontrado um retentor da cambota danificado como apresentado na figura 1.

During the engine runup, a leak was detected around the Ignition Housing that, after duly disassembly, a damaged crankshaft oil seal was found, as shown in figure 1.

Retentor danificado || Damaged oil seal

A causa provável determinada pelo prestador de serviços de manutenção para o incidente de perda de óleo do motor #1 em voo, foi atribuída à falha do retentor da cambota por desgaste promovido pelo contato com o Cubo do Volante do Motor.

Foi ainda determinado que o contato do retentor com o Cubo do Volante do Motor terá ocorrido por uma deficiente instalação do retentor durante os trabalhos de revisão geral (*overhaul*) do motor, ocorrido há menos de 10 horas de trabalho do mesmo.

The probable cause for the engine # 1 inflight oil leakage incident determined by the maintenance service provider was the failure of the crankshaft oil seal retainer due to wear caused by contact with the flywheel hub.

It was also determined that the contact between the retainer and the flywheel hub was due to a defective installation of the retainer during the engine overhaul, which took place less than 10 hours of flight time.

- Avaliação da condição da instalação do retentor em todos os motores intervencionados atualmente em serviço,
- O prestador de serviços de manutenção do motor efetuou a revisão aos protocolos de manutenção de forma especificar e detalhar o procedimento de instalação do retentor e/ou inserir uma segunda verificação do mesmo após a finalizada da instalação.
- O prestador de serviços de manutenção do motor irá consultar o fabricante do motor expondo as evidências e conclusões do evento, obtendo informação

- Oil seal retainer installation and condition in all overhauled engines currently in service,
- The engine maintenance service provider reviewed the maintenance instructions in order to specify and detail the oil seal retainer installation procedure and add a double check inspection after the installation is completed.
- The engine maintenance service provider will contact the engine manufacturer conveying the findings and conclusions of the event, obtaining information
