### Accident Investigation Final Report

All Engines-out Landing Due to Fuel Exhaustion

Air Transat  
Airbus A330-243 marks C-GITS  
Lajes, Azores, Portugal  
24 August 2001

22 / ACCID / GPIAA / 2001

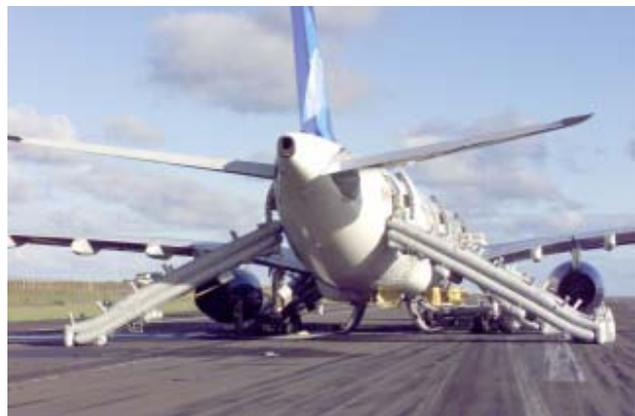
At 06:45, the aircraft crossed the threshold of runway 33 at about 200 knots, touched down hard 1 030 feet down the runway, and bounced back into the air. The second touchdown was at 2 800 feet from the approach end of the runway, and maximum braking was applied. The aircraft came to a stop 7 600 feet from the approach end of the 10 000-foot runway. After the aircraft came to a stop, small fires started in the area of the left main-gear wheels, but these fires were immediately extinguished by the crash rescue response vehicles that were in position for the landing<sup>6</sup>. The Captain ordered an emergency evacuation. Fourteen passengers and two cabin-crew members received minor injuries, and two persons received serious injuries during the emergency evacuation. The aircraft suffered structural damage to the fuselage and to the main landing gear.

**Figure 1 - Aircraft After Landing**

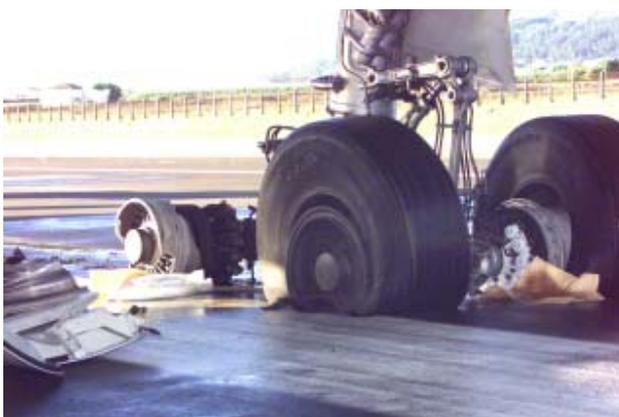
Due to the engines-out condition, the landing was conducted without the brake anti-skid and normal braking systems. Because the emergency brake accumulator only provides for a limited amount of brake applications, full braking was applied and retained at the second touch down, resulting in the main wheels locking up. The tires quickly abraded and deflated at a point between about 300 and 450 feet beyond the second and final touch down. The segments of the main wheels contacting the pavement were worn down to the bearing journals, the left, rear, inboard wheel detached from the axle. Both left and right brake anti-torque links attachment horns on the bottom segments of the main oleos also contacted the pavement; the horns were abraded to the point that some of the links separated from the oleo resulting in the rotation of at least one brake carrier.

Figure 2 - Left-main Boogie

Shedding of brake and wheel components during the landing run also resulted in a combination of punctures and impact damage to the airframe and left engine nacelle.

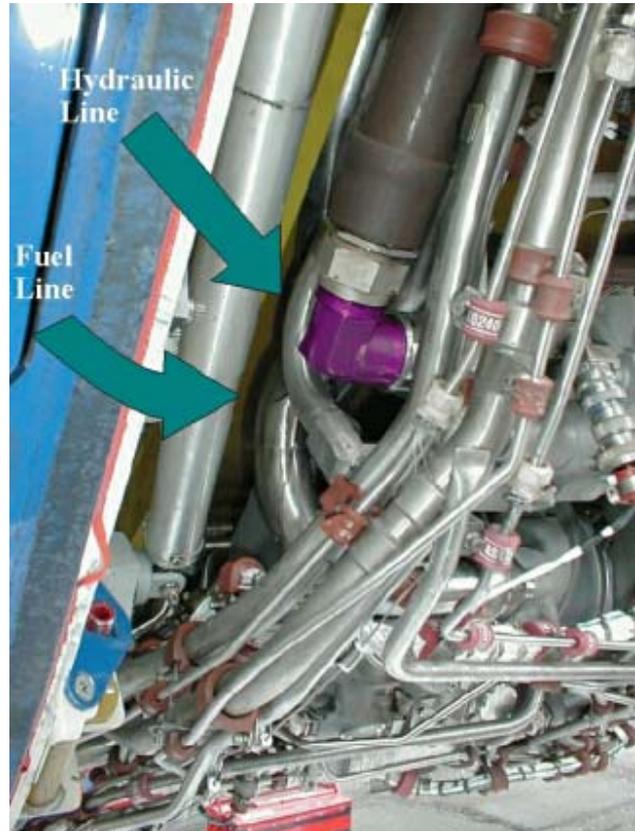
The initial inspection of the right engine following the occurrence uncovered the presence of an L-shaped crack on the inlet fuel tube wall (Part No FK30383). The crack was approximately 3.0 inches (80mm) long, and was spread to a width of about 1/8 inches (2.5mm). In addition, the hydraulic outlet tube (pressure) for the rear hydraulic pump was found to be in hard contact with the fuel tube. The cracking on the fuel tube extended to both sides of a mechanically worn (chafed) area where the tubes came into contact. It was evident that the interference and chafing occurred due to the mismatched installation of the post-mod fuel tube (P/N: FK30383) and pre-mod hydraulic tube (P/N: LJ51006). Based on the DFDR data, it was determined that the fuel leak rate through this cracked reached a maximum of about 13.0 metric tons per hour.

Both reports concluded that the fuel and hydraulic tubes fully matched the drawing characteristics for material, form and shape. The fuel tube wall section was measured and showed that the wear had reduced the wall thickness by 0.005 inches, and that the hard contact had resulted in a dent measuring 0.044 inches deep. The examination concluded that the fuel tube fractured in high cycle fatigue at multiple initiation sites in the bore and the outside diameter, due to a combination of vibratory stresses being superimposed on the tube deformation. Also noted were some scratches and deep scores around the chafed location on both tubes. Report MFR 41281 stated that these marks are believed to have been made at the time of installation of the engine because this was the only time the post-SB fuel line and pre-SB hydraulic lines were mounted adjacent to one another. The report con-

Figure 3 - Right Engine Pipe Contact

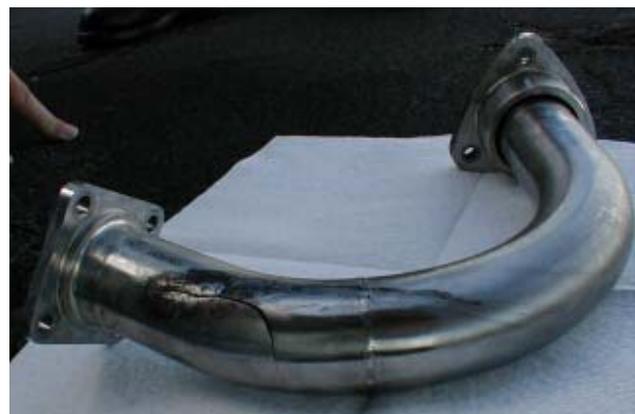
Figure 4 Fuel Pipe Crack & Scratches

cluded that the scratches and scores were directionally aligned and that they could have been caused from repeated contact from a blunt instrument, such as a screwdriver being inserted between the tubes in order to force a clearance between them. There were no cracks initiated from the score or scratch marks.

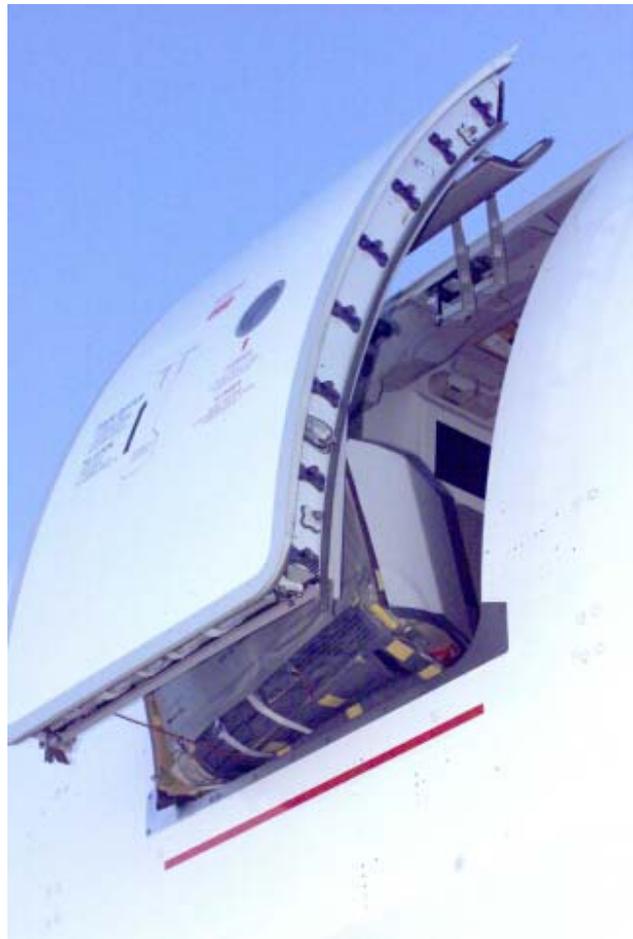
Sometime after the landing, fire-rescue crews, in attempting to eliminate the hazard of the escape slide inflating within the cabin, used a pry-tool to release the slide and open the door. Reportedly, when the door was opened, the slide fell out the door and only inflated partially.

Figure 6 - Door L3 Jammed

Inspection of the L3 exit did not reveal any damage to the door or frame, other than minor scratches and minor damage to the plastic panel in the area where the pry bar was used. When operated by investigators, the door opened and closed without any restriction and no mechanical distortion or malfunction was found either with the arming system or with the locking/unlocking of the girt bar. An examination of the power-assist unit indicated that it had been activated.

Conclusive finding as to the cause of the door jam could not be made, primarily because of the missing components. Notwithstanding, interviews and photos confirm that the slide had not released completely from the door, and that the bustle rails/rail adapters may have jammed.
