GABINETE DE PREVENÇÃO E INVESTIGAÇÃO DE ACIDENTES COM AERONAVES
(G.P.I.A.A.)

INCIDENT REPORT
WITH AN AIR LUXOR **AIRBUS**,
MODEL **A-320**, REGISTRATION
CS-TQE
OCCURRED IN MADEIRA AIRPORT
ON THE 2ND OF JANUARY OF 2004

TECHNICAL REPORT Nr. 01/INCID/2004

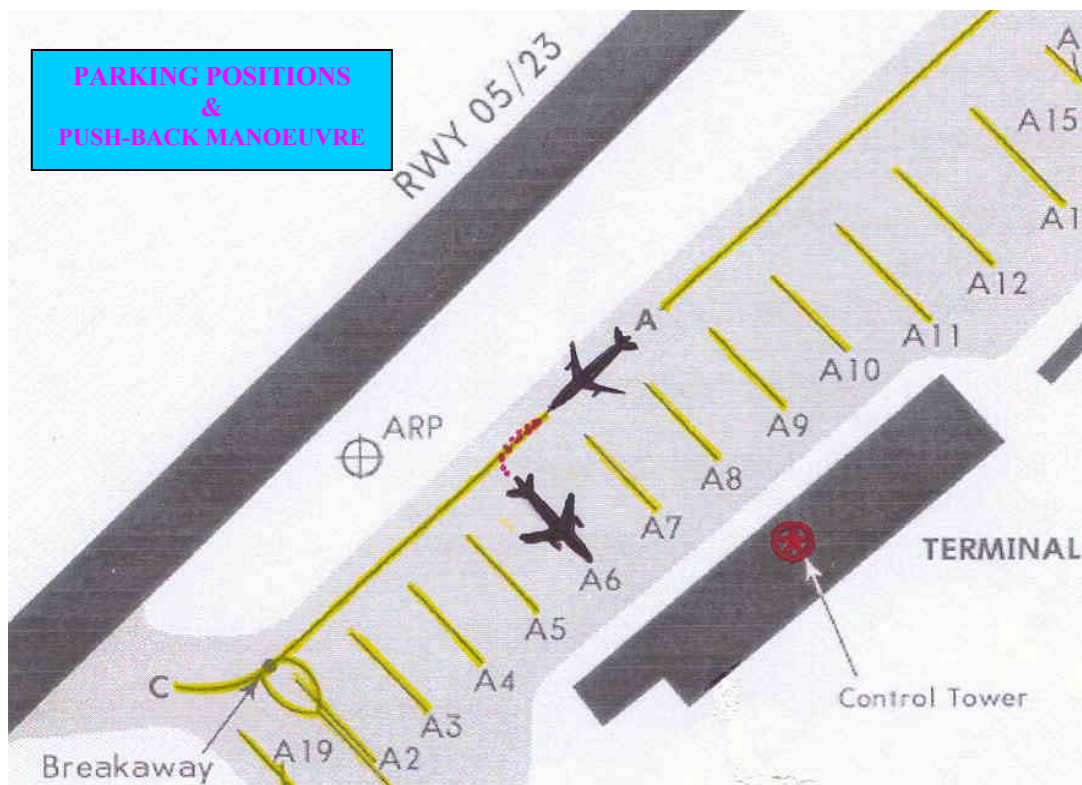
Picture Nr. 1

Once cleared from Tower (TWR), assisted by a ramp official, the Capt. initiated the “push-back” into taxi lane A (*picture nr. 1*), starting engine Nr. 2 during the manoeuvre.

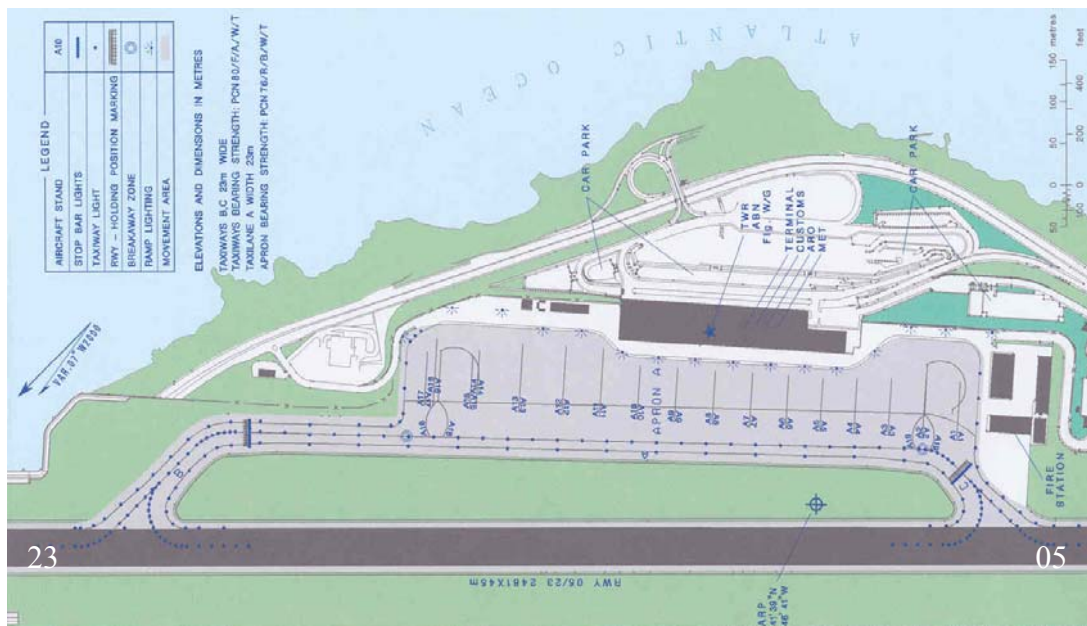
Picture Nr. 2

Madeira International Airport has a 2481 x 45 metres runway and an apron with 15 narrow body aircraft capacity, with two opposite taxiways to access the runway (*picture nr. 2*).

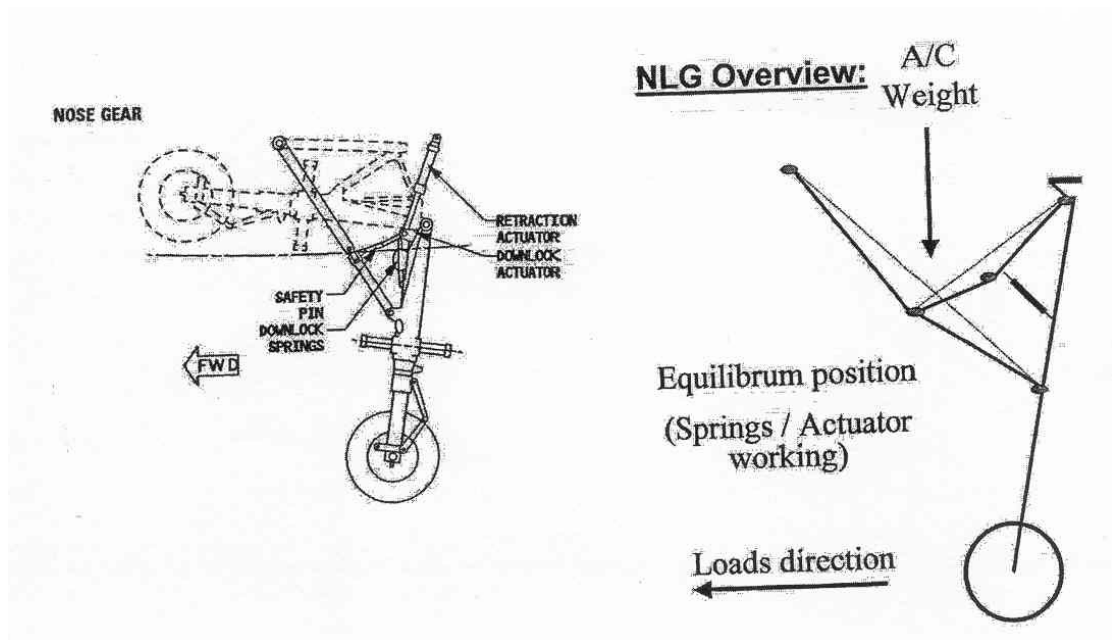
Picture Nr. 3

Landing gear geometry grants that, once locked down, the gear can not be raised unless the hydraulic system is operated to deactivate the down locks and undo the geometric locks (*pictures 3 & 4*).

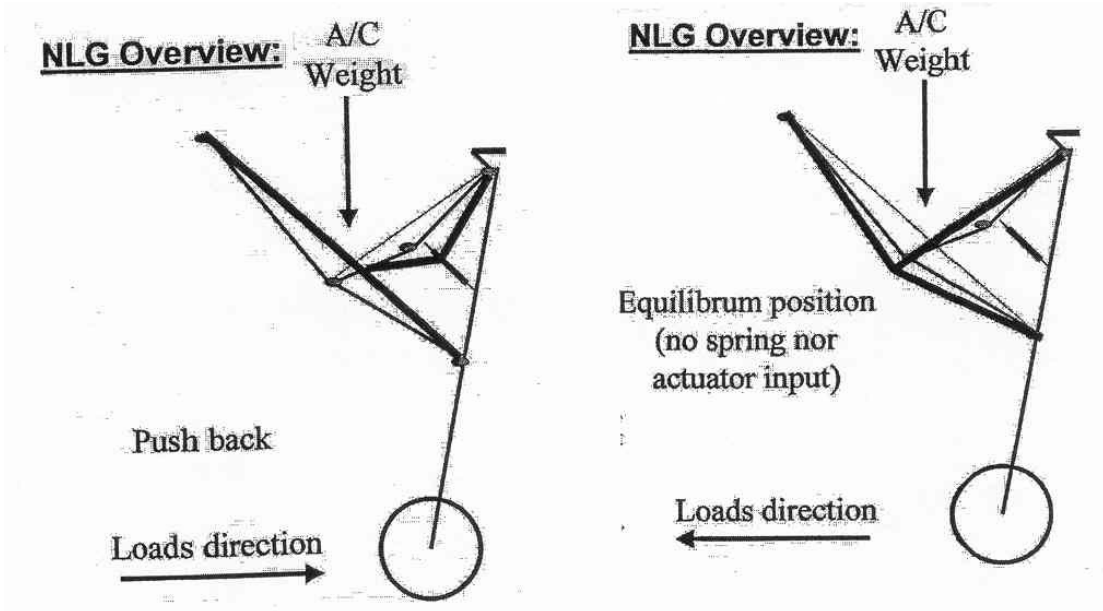
Picture Nr. 4

Even during push-back or other ground manoeuvres, this geometry grants the gear locking and makes impossible its mechanical retraction (*picture nr. 4*), unless there is a structural failure.

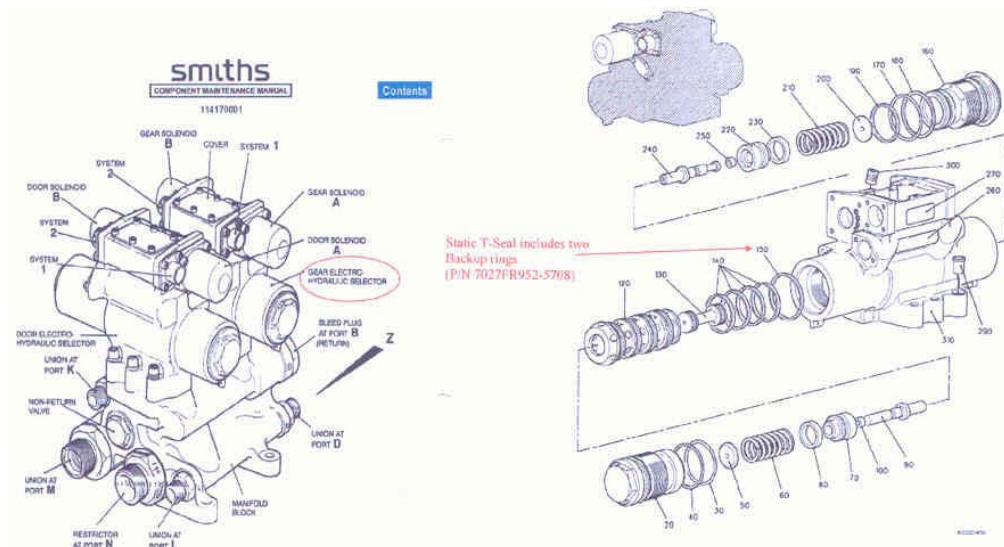
Picture Nr. 5

Taking into account these principles we shall investigate the hydraulic operation of landing gear, more precisely the landing gear selector valve (*picture nr. 5*), looking for clues.

After disassembly (*picture 5 & 6*) an installation error was detected regarding a sealing ring (P/N 7027FR952-5708).

- 3.1.11 This anomaly was due to a deficient manufacture process.
- 3.1.12 This anomaly induced an abnormal pressurisation of landing gear retracting line.

- 1 A faulty seal (P/N 7027 FR 952-5708), resulting from a defective manufacture process, allowed an abnormal pressure build up in landing gear retracting line ;
- 2 The landing gear downlocks withdrawal, most probably caused by a momentary de-energizing of landing gear door's selector valve "A" solenoid, during the transient period of power transfer from APU GEN to ENG #1 GEN.

In view of these findings and considering that the recommendations 4.2, 4.3 and 4.4 stated in SCF/SYS/N/09/7430 have been implemented, the Investigation Commission recommends that Airbus issues a Service Bulletin to mandate all operators, using the same type of landing gear selector valve, to perform an inspection of static seals for any assembly fault.

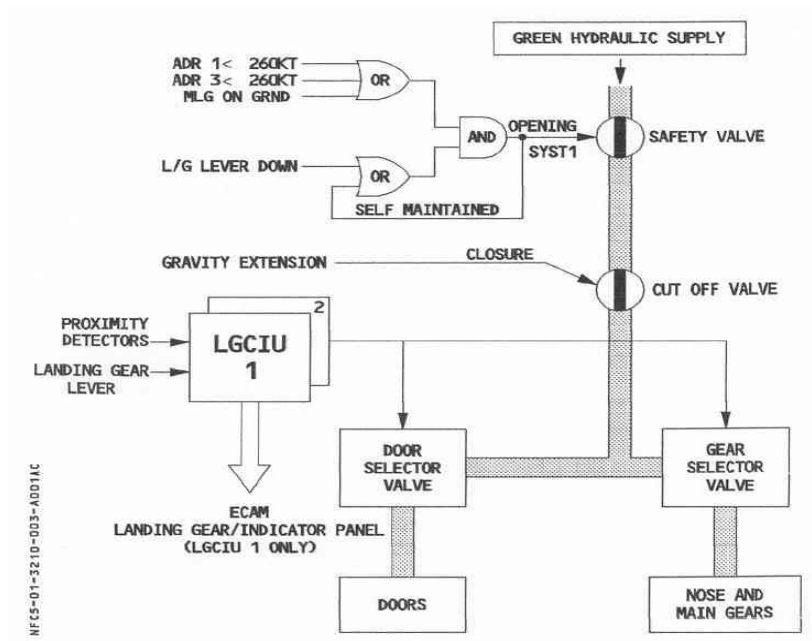
Picture Nr. 10

A-320 landing gear comprises two main legs, retracting sideways inboard, and a nose leg, retracting forward. Wheels are stowed inside respective bays, enclosed by hydraulic actuating doors.

Landing gear is hydraulically actuated, but electrically controlled through two electronic units (LGCIU), which automatically switch over from one to another, after each complete gear cycle or in case of failure.

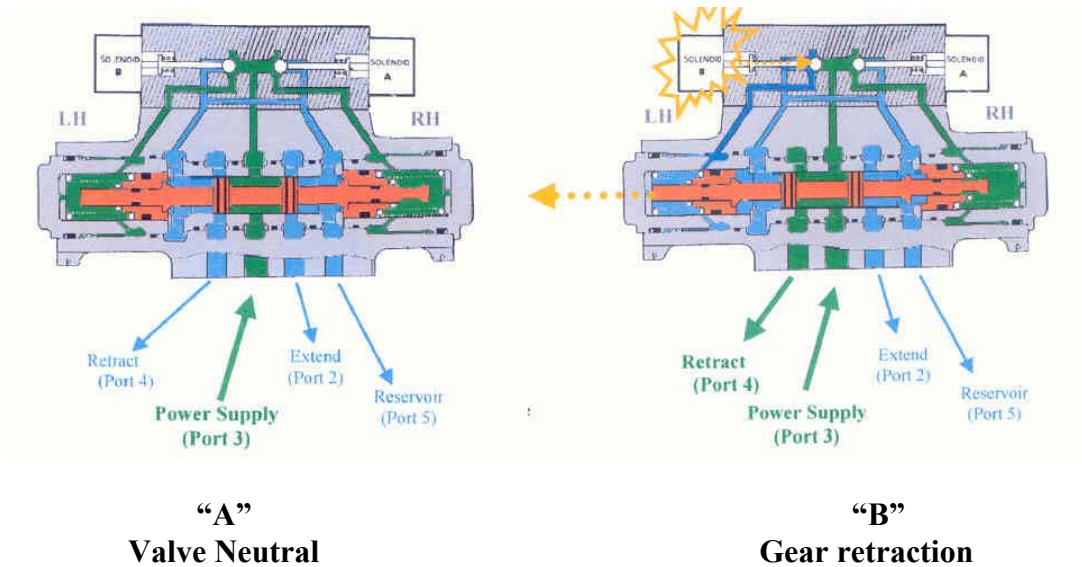
Picture Nr. 11

Gear retraction line is pressurised when gear selector valve is activated, by energizing “B” solenoid (*picture 11 “B”*).

For the retract line to be pressurised, the gear control valve core must move to the left (*picture 11*). This is achieved when command pressure drops on left side (normally accomplished by energizing “B” solenoid).

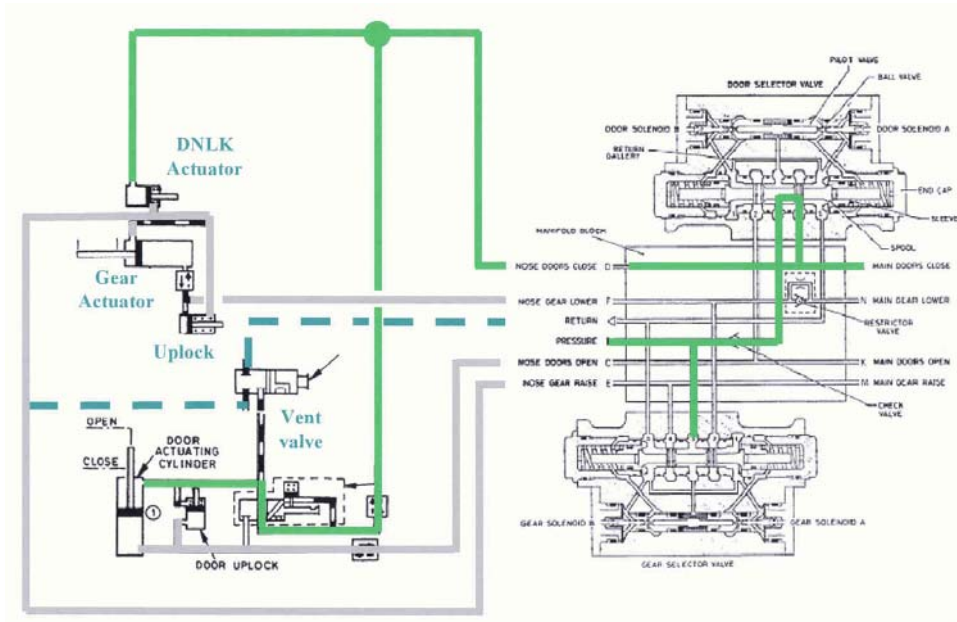
Picture Nr. 12

When the aircraft is on the ground, with gear down and locked (picture 12), the active LGCIU sends a command to energize the “A” solenoid and pressurise the line to close gear doors and keep gear downlocks set. The line is kept pressurised in order to allow nose wheel steering operation.

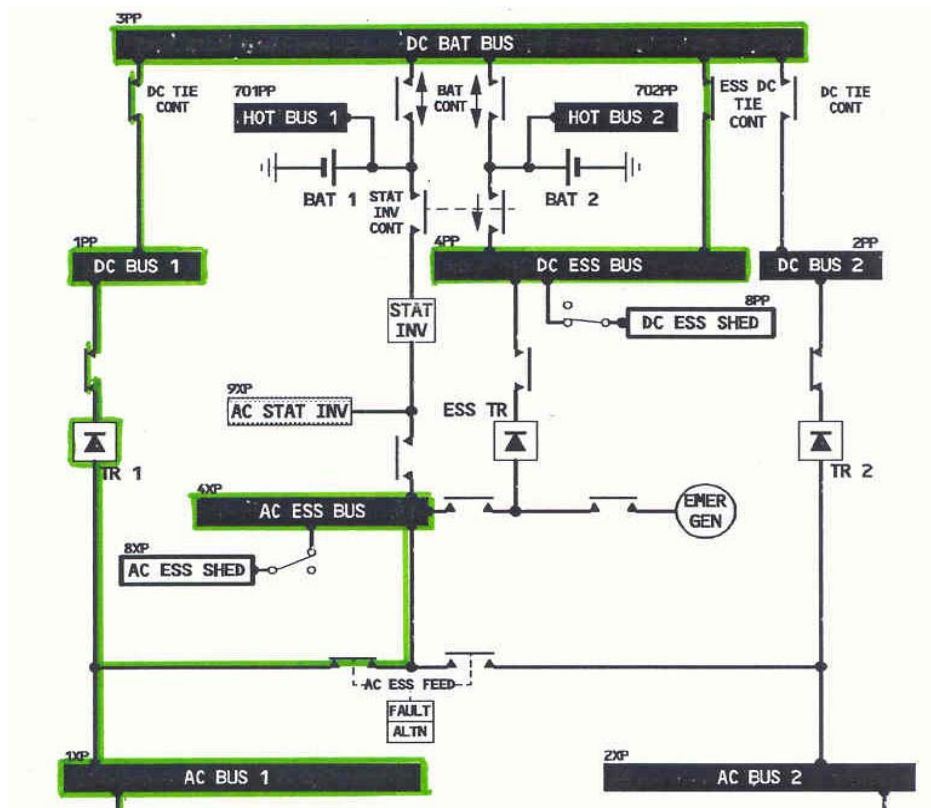
Picture Nr. 14

As per aircraft electrical system the LG doors operating valve solenoids are fed by “DC ESS BUS”, which is normally powered by “AC BUS 1” (picture 14).

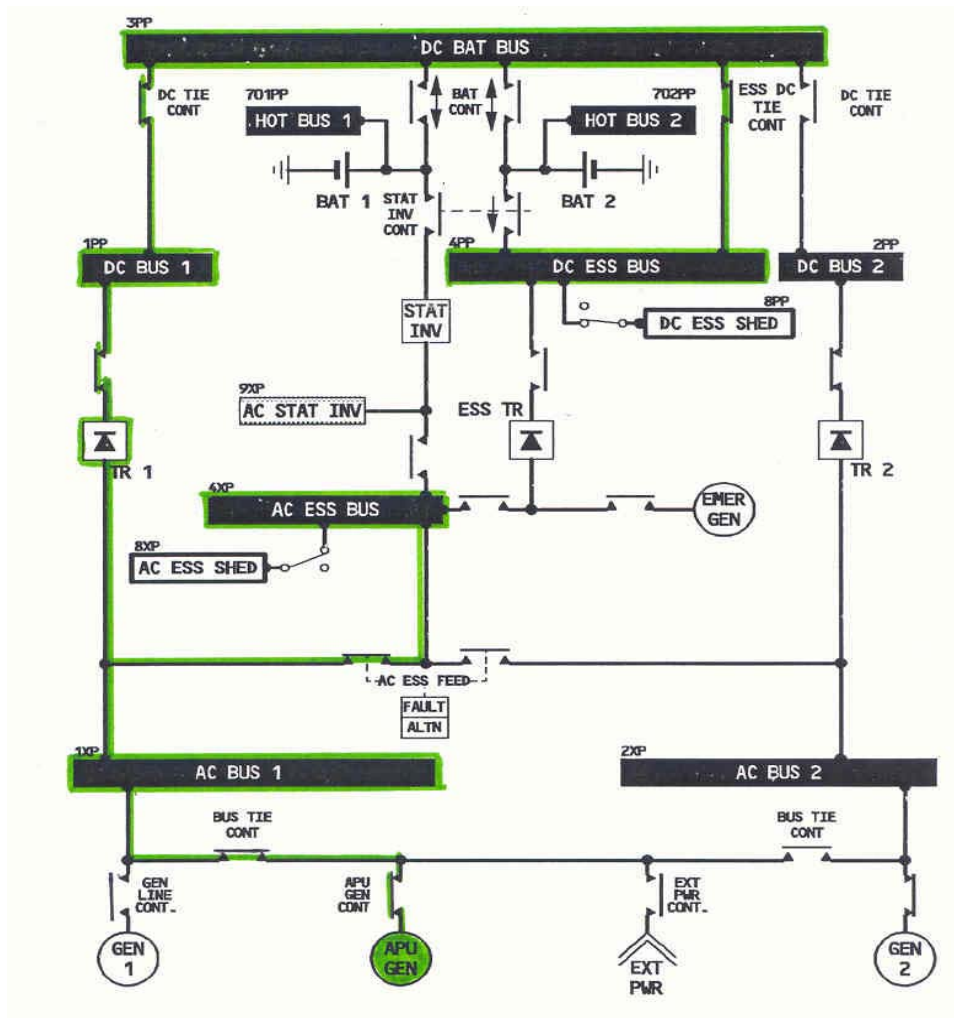
Picture Nr. 15

During push-back, AC BUS 1 was powered by APU and AC BUS 2 was power by APU, until engine 2 was started and accelerated to a regime where engine generated electrical power reached the necessary properties to supply AC BUS 2 (*picture 15*).

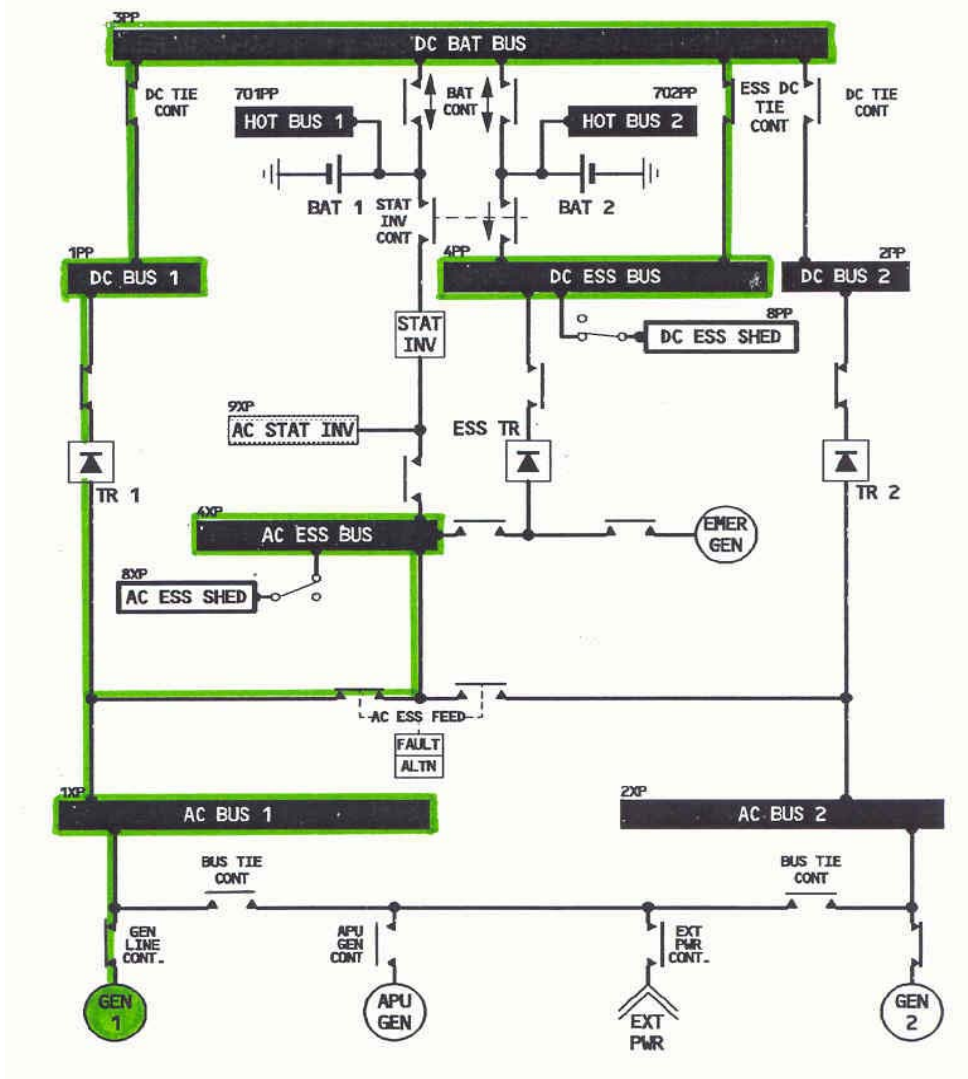
Picture Nr. 16

Once finished the push-back, Capt started engine #1 and, as soon as current met required properties, generator #1 automatically switched over and started feeding AC BUS 1, whilst APU generator was disconnected from operating buses (*picture 16*).
