FINAL ACCIDENT REPORT

AIR TRACTOR - 802A

EC-JLB

FINAL ACCIDENT REPORT Nr. 12/ACCID/2012

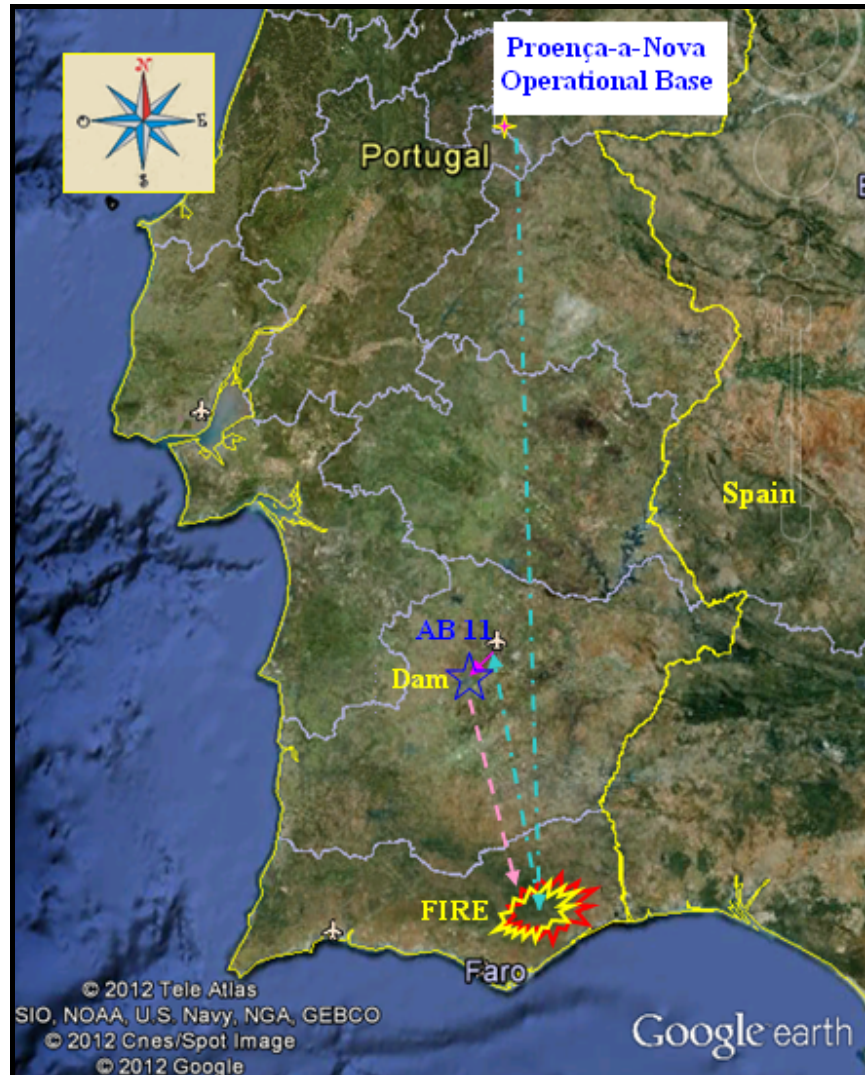
Picture Nr 1

By 12:10, both aircraft teams took-off in sequence, heading to "Roxo Dam", close to the aerodrome, where they expected to make water refuelling, prior to proceed to fire area again (*picture nr 1*).

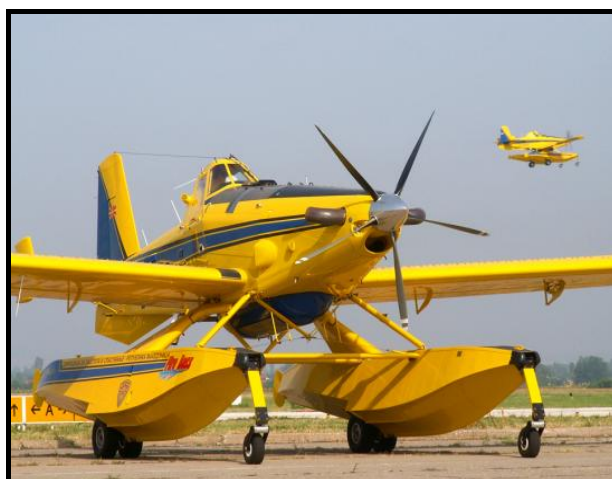
Picture Nr 4

The aircraft (*picture nr 4*) was a single engine, low wing and single pilot aircraft, specially prepared for wildfire fighting. Deriving from a previous generation of fire fighters, it was equipped with a water scooping system capable of scooping 820 USG of water in 30 seconds, for what floats had been installed, incorporating a wheeled undercarriage for land operation, becoming more versatile and efficient than his predecessor.

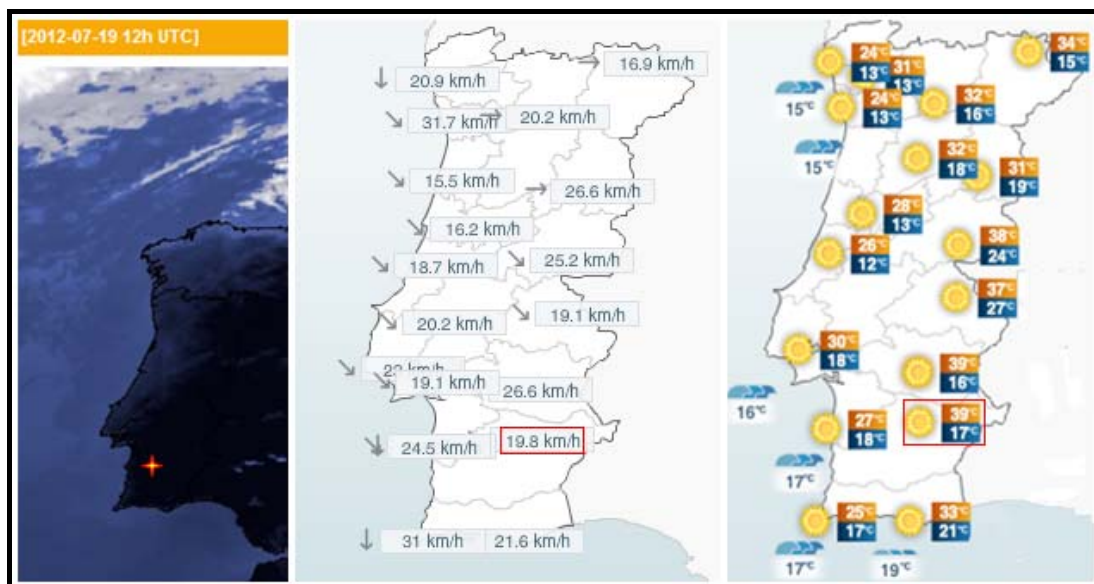
Picture Nr 5

The weather was fine, with clear sky, light to moderate North-westerly wind, high air temperature, capable of reaching 39°C (*picture nr 5*).

By accident time, the wind was blowing from 310° with 08kt and the temperature was 33°C, as meteo information from Beja military aerodrome (LPBJ) bellow.
