***Tail strike landing on runway 30
João Paulo II Airport
Ponta Delgada, Azores
2nd of March 2013, 21:10 UTC
Airbus 310-300***

GPIAA SAFETY REPORT

02/ACCID/2013

FINAL

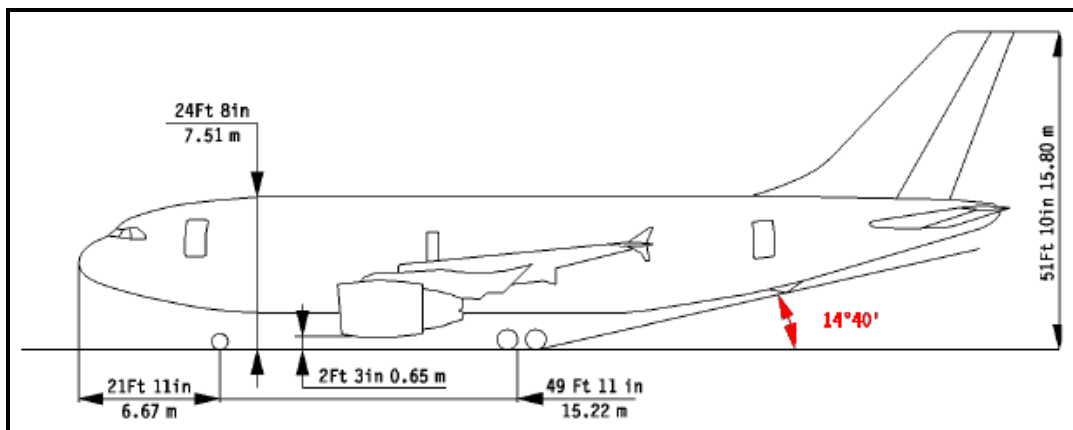
Picture nº3

Referring to the Aircraft Flight Crew Operating Manual (FCOM) issued by the manufacturer we find out that the geometry of A310-300, with main gear oleos⁴ struts extended allows a 14° 40' clearance for the tail to contact the ground (Picture nº3) decreasing to a 13° with main landing gear shock absorbers fully compressed.

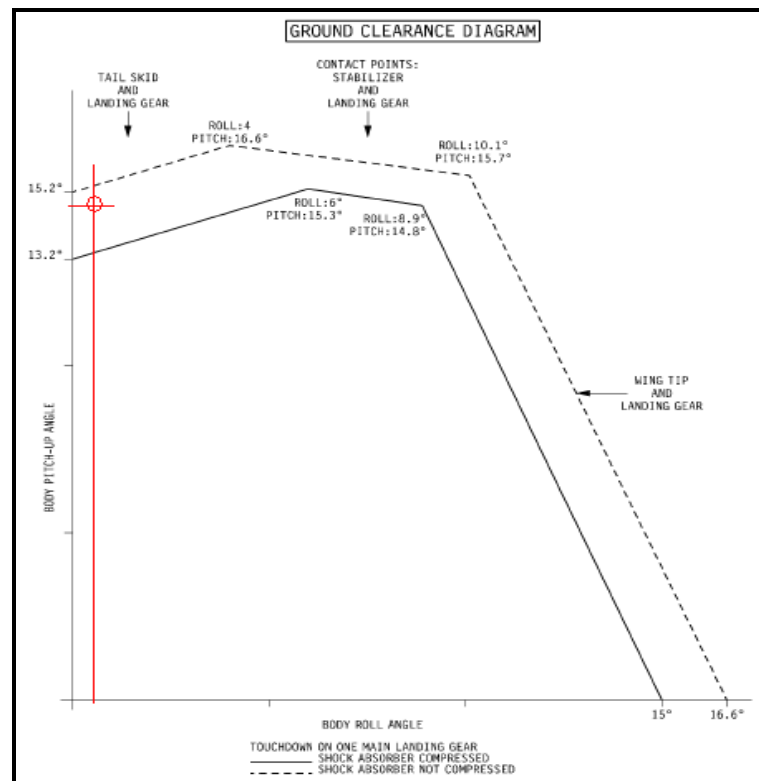
Diagram n°2

- ✓ When the aircraft touched down for the second time and main gear shock absorbers compressed pitch angle exceeded the aircraft's geometry limit for compressed absorbers, making the tail structure strike the ground, as confirmed by "Ground Clearance Diagram" (Diagram n°2), referred on Flight Crew Operating Manual (FCOM) 2.03.22.
