EMBRAER E190-100LR

AIR ASTANA / P4-KCJ

ACCIDENT  
SAFETY INVESTIGATION  
FINAL REPORT

[08/ACCID/2018]

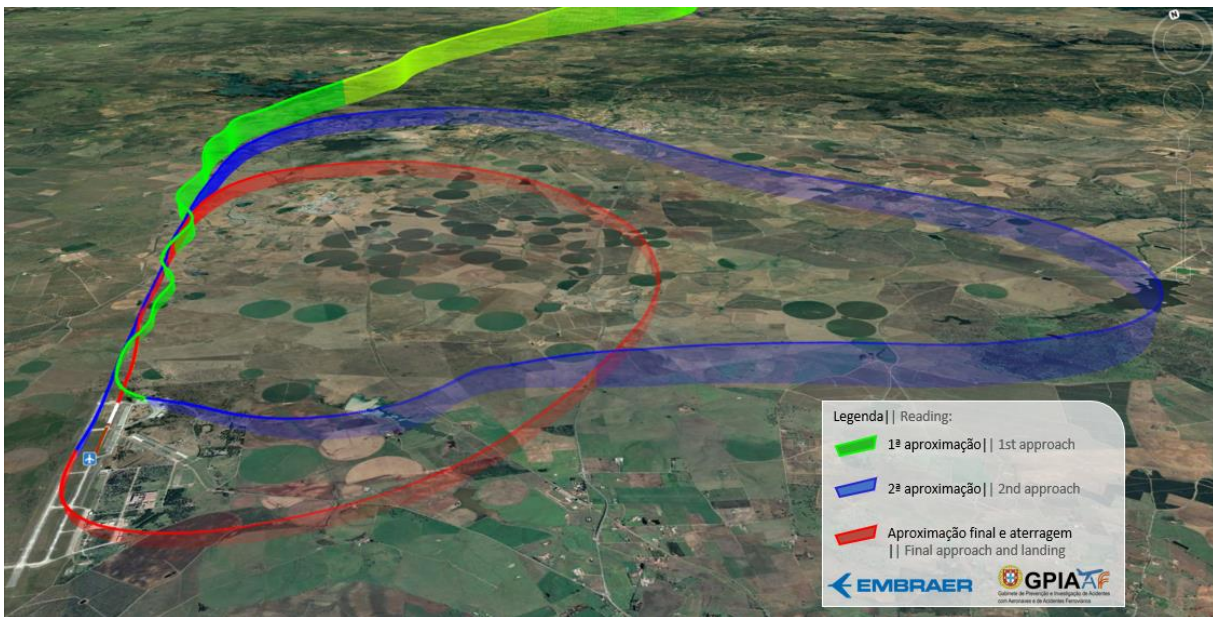
**Figura 3 || Figure 3**

After two non-stabilised approaches, at 15:27 the crew managed to safely land the aircraft on runway 19L after the third approach. The intended runway was 19R, however the aircraft drifted to the left.

Trajectoria na aproximação e aterragem em LPBJ  
 Fonte: DVDR e google Earth

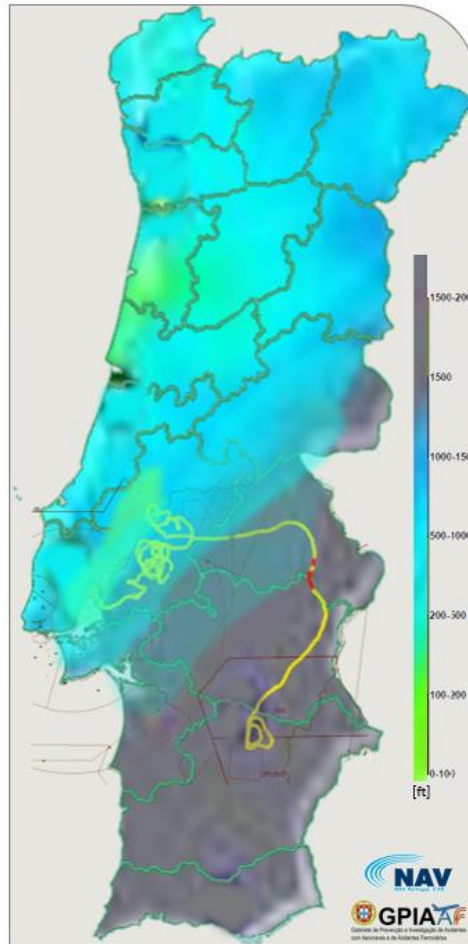
**Figura 12** || **Figure 12**

Detalhe meteorológico com teto das nuvens à hora da decolagem, com o percurso da aeronave sobreposto

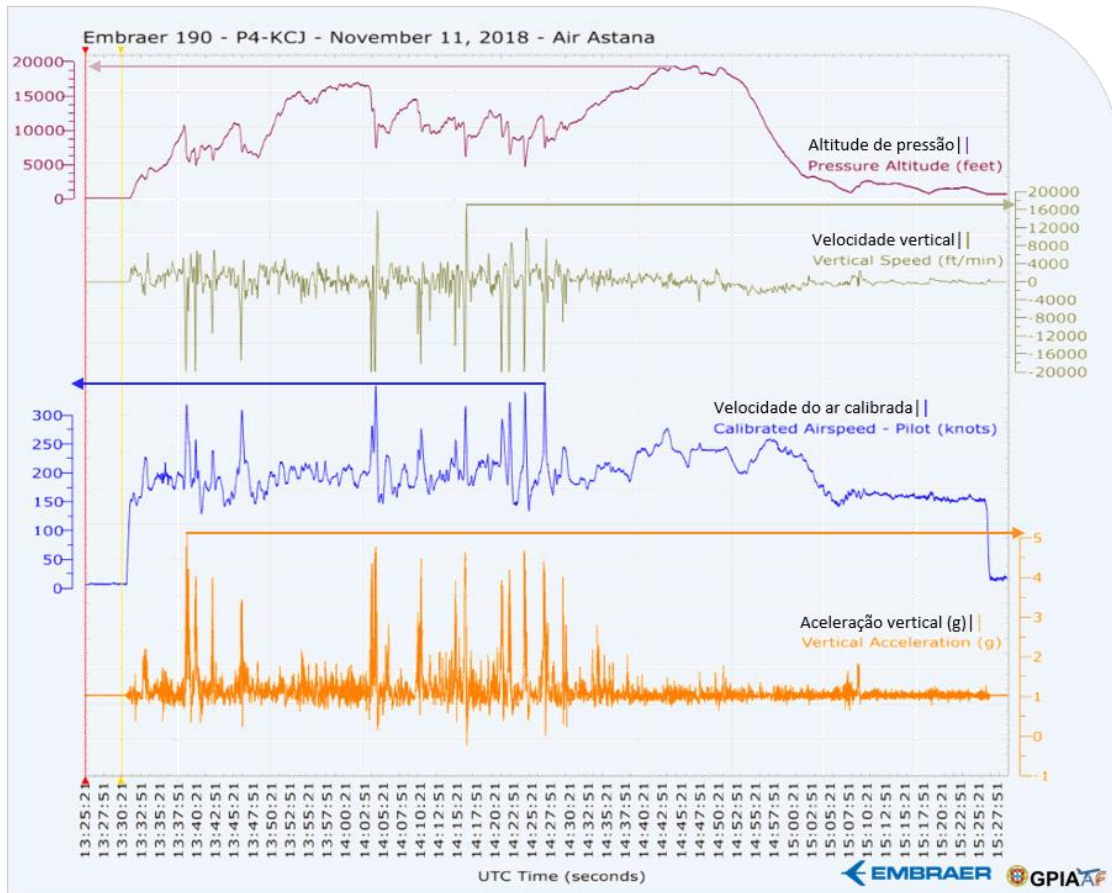
Figura 13 || Figure 13

significant deviations from the normal aircraft operation.

Dados básicos de voo dos DVDR || DVDR basic data

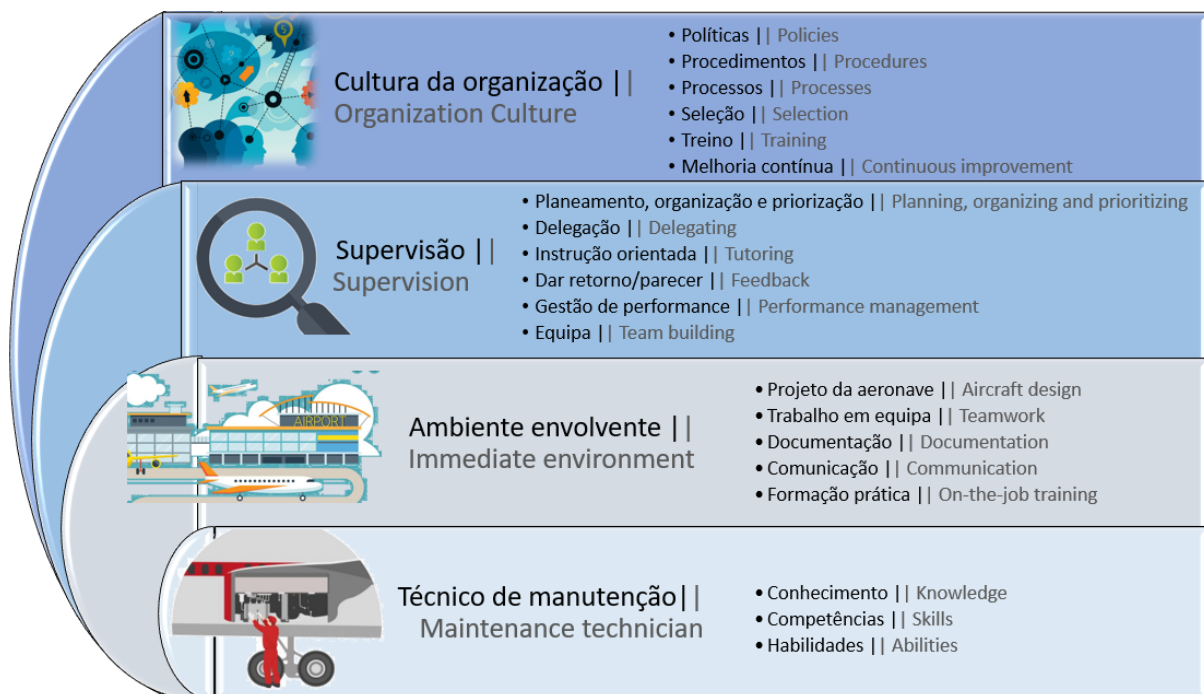
Figura 21 || Figure 21

In this way, the human error that occurred during the cable support replacement, led the investigation to explore the systemic aspects that underlie it.

Cadeia de fatores identificados || Identified involved factors

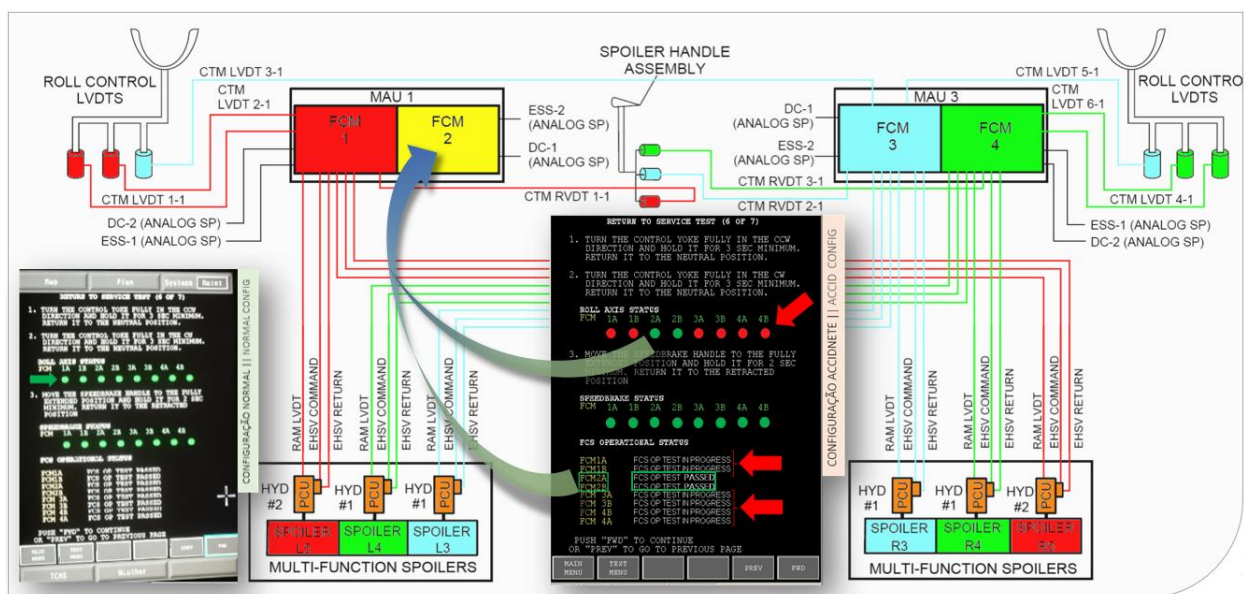
Figura 28 || Figure 28

It was clear that the absence of a fault indication on both FCM2 channels and, as opposed to the failure on all other FCM, was related to the system architecture, where the FCM2 does not receive inputs from control column position LVDTs or from spoiler actuators.

Not receiving a valid condition relating the commanded position to the received ailerons actual position in MAU 1 and 3 through the AFCS/AIOP 1A and 2B plates respectively, the CBIT were not exercised and, consequently, it did not allow to clean the FCM NVM 1, 3 and 4.

Arquitetura do sistema de comando em malha fechada dos FCM
