### Accident Investigation Final Report

All Engines-out Landing Due to Fuel Exhaustion

Air Transat  
Airbus A330-243 marks C-GITS  
Lajes, Azores, Portugal  
24 August 2001

22 / ACCID / GPIAA / 2001

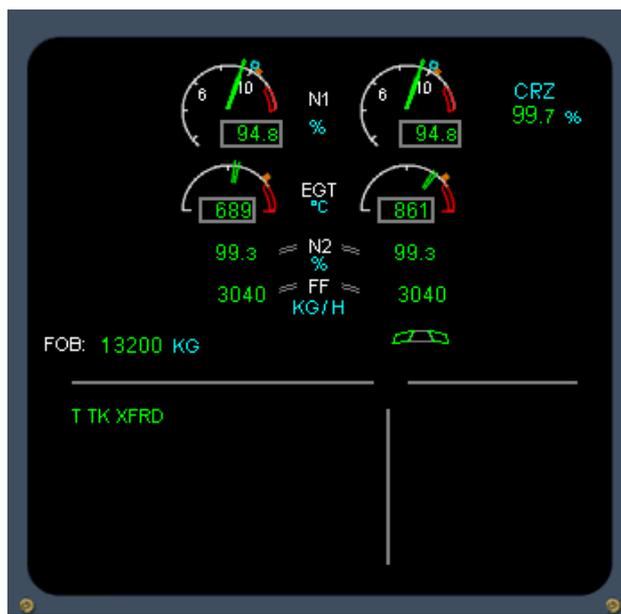
Figure 5 - E/WD & Trim Tank Transferred Memo

A trim tank is located in the THS. The trim tank transfer system is a fully automatic mode system that controls the center of gravity of the aircraft. When the aircraft is in cruise, the primary Fuel Control and Management Computer (FCMC) calculates the C of G and compares the result to a target value that depends on the aircraft actual weight. From this calculation, the FCMC optimizes the C of G by deciding to transfer fuel to or from the trim tank. There is normally only one aft transfer at the beginning of the flight. During the flight, there is a series of small forward transfers. If the actual C of G is different from the target C of G by more than 0.5% and the aircraft is above Flight Level 255, an appropriate transfer occurs. If an inner tank quantity drops below 4 000 kg, forward transfer also occurs to maintain the fuel in the inner tanks between 4 000 kg and 5 000 kg until the trim tank is empty. If during a forward transfer the inner tanks are out of balance by more than 500 kg, the transfer is automatically stopped on the heaviest side until the fuel balance is achieved. A final forward transfer occurs when the time to destination is less than 35 minutes, when either set of wing tanks is below 4.0 tons, or when the aircraft descends through FL245. When fuel is being transferred, a “TRIM TANK XFR” message appears on the ECAM Memo screen; when the trim tank is empty, a “TRIM TANK XFRD” message appears on the ECAM Memo portion of the E/WD screen.
