PRELIMINARY REPORT

Reference:	29/ACCID/2009
Date/Time:	AUG/14/2009 at 18:10 UTC (19:10 LOCAL)
Local:	Residential quarter of Almeirim, Évora
Aircraft:	Beechcraft 99A; s/n U79; registration: F-BTME; Engines: 2X PT6A/20; s/n: PCE-21733 + PCE-21360; Propellers: 2X Hartzell HCB3TH3B; s/n: BUA22020 + BUA22522
Pilot:	Male, 40 years, FAA Private Pilot License (Aeroplanes) ?, 400 hours ?
Type of Flight:	Air Work, Parachute jumping
People on Board:	1 Pilot + 14 Passengers
Personal Injuries:	1 Pilot + 1 Passenger Fatal Injuries
Aircraft Damage:	Destroyed

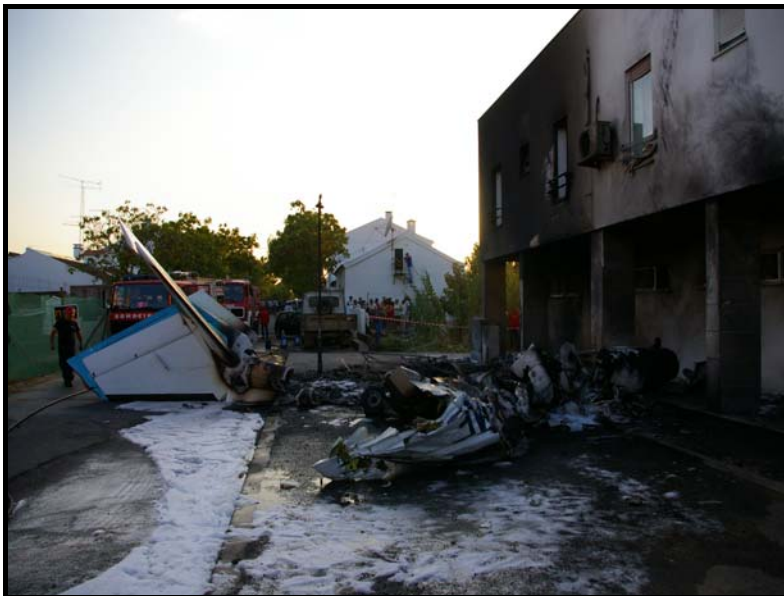
When climbing through 10 500', the pilot informed the passengers that he had lost left engine and they should leave the aircraft as soon as possible. All 13 parachutists jumped, in sequence, and the pilot, with the other passenger, started descending for landing on runway 01 at Évora aerodrome (LPEV), without calling the Tower to inform the situation or transmit any distress message.

According visual witnesses, located at the aerodrome, the aircraft approached the runway, slightly out of runway axis, at excessive speed, the pilot being unable to stop the aircraft on runway distance available. Reaching runway end, still with high speed, he decided to reject landing and try a single engine go-around. Power was increased on right engine and the aircraft started climbing slowly and turning to the left. Due some terrain irregularity, viewers lost aircraft sight for some moments until it appeared again, near the houses of nearby residential quarter, with a significant bank, prior to hit one house's roof and crash on the street, upside down, being engulfed in fire, immediately.

On site first investigation: Fuselage and right wing were consumed by fire, while left wing and engine were damaged by impact. Impact forces caused engine shafts to broken and respective propellers were separated. None of them was feathered and the blades were damaged, the left one showing signs of loss of power while the right one was running at normal power settings. The only part spared by fire was the empennage, where trim tabs could be confirmed in neutral position (rudder and elevator).

Cockpit was so destroyed that it was impossible to determine engine and flight controls command levers position. Even so, left wing flap showed a position equivalent to 30° flaps down and landing gear legs fractures and position seemed to indicate the gear was extended before collision.
