GPIAA – GABINETE DE PREVENÇÃO E INVESTIGAÇÃO DE ACIDENTES COM AERONAVES

NOTICE OF AIRCRAFT INCIDENT

PROCESS Nr: 07/INCID/2015			
Date/Time (local): 19-05-2015 at 11:20 UTC (12:20)		Location: LIS/LPPT Lisbon Int. Airport	
Aircraft: A320-214	Type: Twin turbofan	Registration: OO-SNB	Serial Nr: 1493
Operator	Brussels Airlines		
Origin/Destination	EBBR (Brussels) / LPPT (Lisbon)		
People on board	150		
Injuries	Crew	Passengers	Others
Fatal	-	-	-
Serious	-	-	-
Minor / None	06	144	-
Aircraft damage: Damage to the engine # 1 Air Intake Nose Cowl.

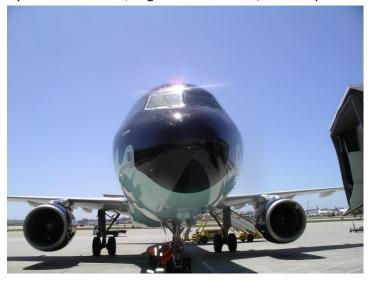
Entrance into the parking stand was carried out with the aid of Marshalling, the parking stand is equipped with an automatic guidance system, known as APIS (*Aircraft Positioning and Information System*), a laser-based technology, which identifies and guides the aircraft to stop in the correct point corresponding to its type, to disembark the passengers through the bridge.

The *APIS* system did not identify the aircraft, not giving information to the pilot stop in position corresponding to the type of aircraft A320.

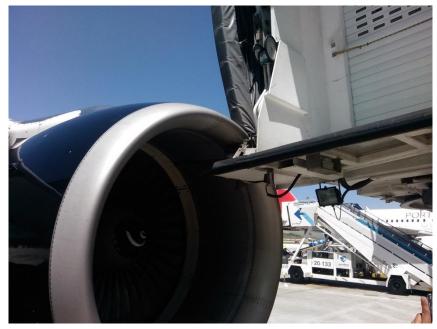
The aircraft stopped a few meters ahead having struck with the nacelle of the engine # 1 air inlet in the bridge that was in its parking position.
